# Appendix 5: Habitat Trends and Restoration

## 1986-1997

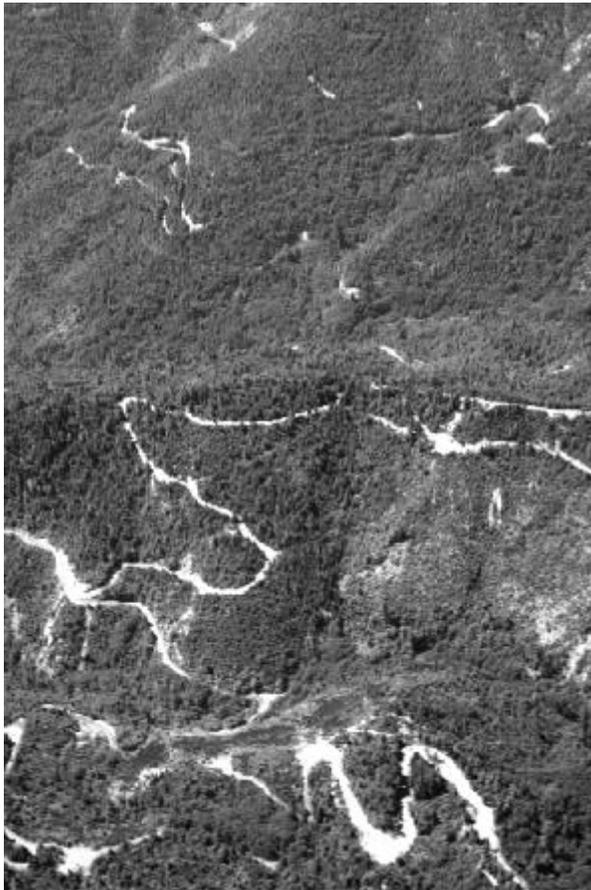
**Hunter Creek:** Hunter Creek has almost no mature forest in its entire watershed. The combination of wildfire in 1988 and intensive timber harvest over the last two decades has left the watershed in a very unstable condition. Steep upland areas have road networks that were built for logging but which are now poorly maintained (Figure A5-1). Several miles of the lower reaches of Hunter Creek still run underground as a result of severe aggradation (Figure A5-2). Over \$100,000 has been spent on habitat improvement structures in Hunter Creek in the reach above where it flows underground. Hopelain (in press) inventoried in-stream structures in 53 northern California streams, including Hunter Creek (see In-Stream Structures in this chapter). Hunter Creek had one of the five lowest scores relative to other streams measured. No photos or data were available from this stream after the January 1997 storm but a post flood reconnaissance was conducted and results of the surveys should be available in the future (John Schwabe, personal communication).

Figure A5-1. Upper Hunter Creek watershed with deteriorating road networks. October 1990.

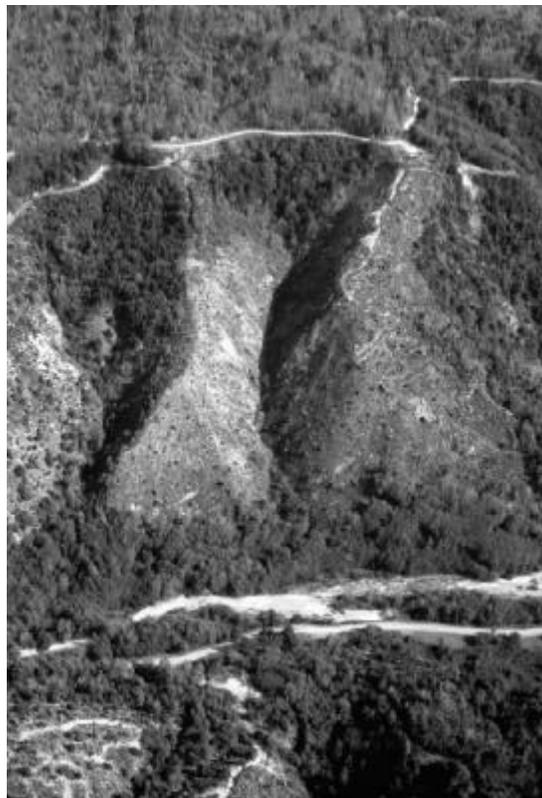
Figure A5-2. Hunter Creek running underground in its lower reaches. October 1990.

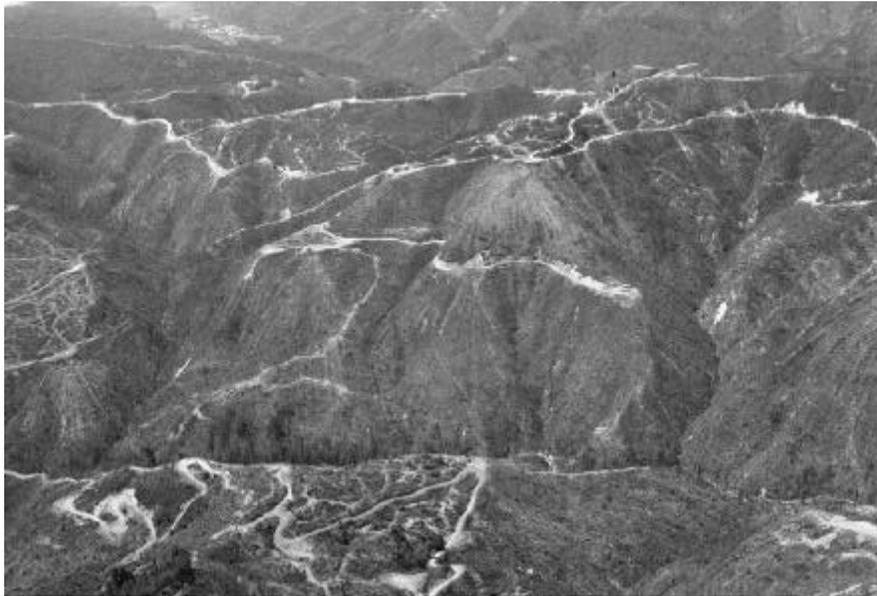
**Terwar Creek:** This watershed has been disturbed in over 90% of its area since 1978 by green timber sales, fire and salvage logging (Figure A5-3). Coates and Miller (1980) pointed out that harvest of over 30% per decade in Terwar Creek would lead to unacceptably high sediment yield and other cumulative watershed effects. Timber harvest has continued to the present and. CDFG has tried to halt timber sales due to requirements for old growth retention in the California Forest Practice Rules but their non-concurrence was over-ridden and timber harvest continued (Bill Condon, personal communication). Terwar Creek, like Hunter Creek, runs underground as a result of severe aggradation in lower reaches during low flows in late summer. The January 1997 flood transported very large quantities of gravel through lower Terwar Creek, negatively impacting private agricultural land and threatening a community water supply (Mark Meissner, NRCS Eureka).

Figure A5-3. Terwar Creek watershed on private industrial timberlands. October, 1990.

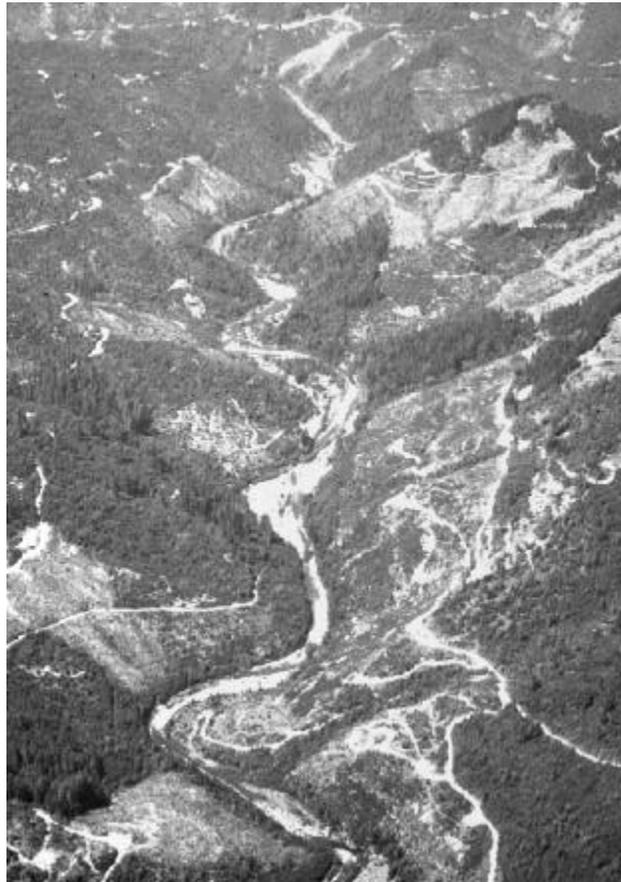
Figure A5-4. Lower Blue Creek inner gorge area with recent clear-cut timber harvests in the riparian zone. October 1990.

**Blue Creek:** Lower Blue Creek on private, industrial timber lands has been extensively logged, including in the riparian zone during the course of the Restoration Program (Figure A5-4); consequently, fish habitat has deteriorated since 1986. The channel of lower Blue Creek has widened substantially in response to an over-supply of sediment related to logging activities. USFWS (1993) has expressed concern over gravel quality and stability in lower Blue Creek with regard to survival of fall chinook salmon redds. The West Fork of Blue Creek has been heavily logged and has an extensive road network. Although a complete survey has not been conducted, weirs in the West Fork of Blue Creek were at least partially destroyed by the 1997 storm. Difficulty maintaining in-stream structures would be expected because most of the West Fork is in early seral conditions and there is an extensive un-maintained road network. Logging on private lands in inner gorge areas of lower Blue Creek was continuing during winter 1997.

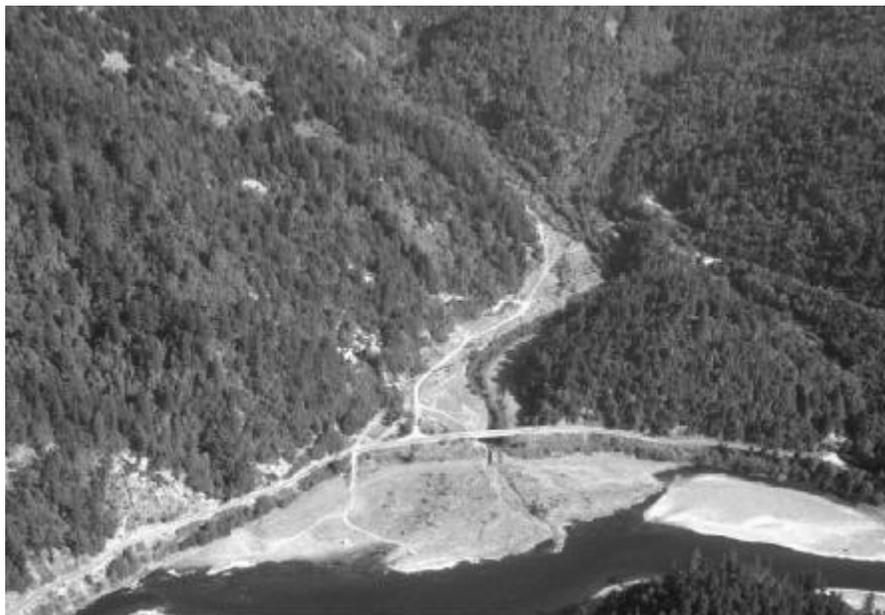
**Other Lower Klamath Tributaries:** Of the 17 streams sampled for juvenile salmonids by the Yurok Tribe, 14 run under ground in their lower reaches during summer (Voight and Gale, 1998) (Figure A5-6). Major sources of sediment, in the form of abandoned road networks, exist in all these watersheds. It is unlikely that these streams will go into recovery and regain surface flow in the near future unless hillslopes are stabilized and watersheds allowed to rest (Roper et al., 1997). Hopelain (in press) found low success rates for in-stream structures in Tarup Creek, similar to Hunter Creek (see In-Stream Structures). A post 1997 flood inventory for lower Klamath tributaries has been conducted but results were not available at the time this report went to press.

Figure A5-6. Cappell Creek represents a typical Lower Klamath Basin tributary delta. These large sediment deposits cause the streams to go under ground in late summer.

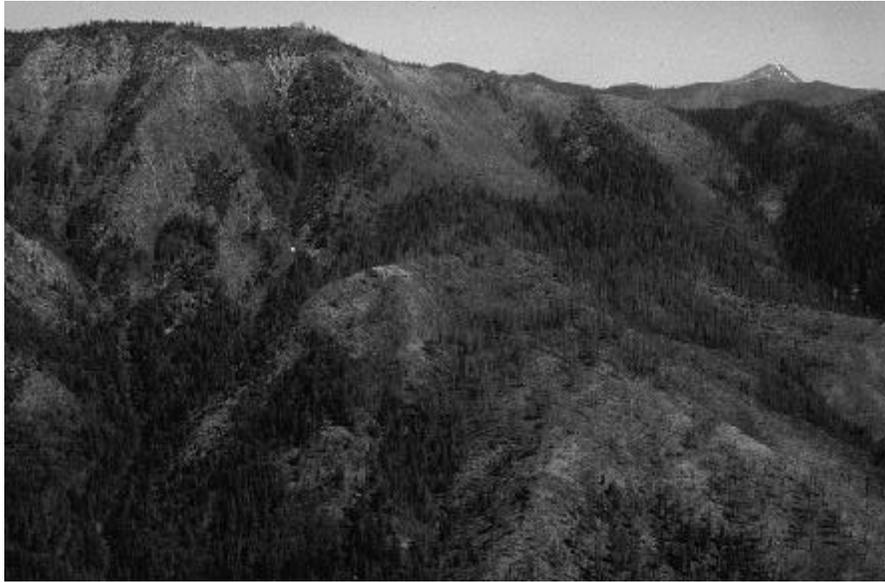
**Dillon Creek:** While Dillon Creek experienced extensive burns in 1994 and 1996 (Figure A5-9), it still produces some of the highest quality water in the Klamath Basin. Large areas of the Dillon Creek watershed were proposed for salvage logging in 1996 but community pressure forced the USFS to confine activity to the perimeter of the watershed. Sediment yield may still increase 30 years after a fire, as root strength of burned trees is lost. No landslides occurred as a result of the 1997 storm but there were 14 road failures (De La Fuente, 1998).

Figure A5-9. Dillon Creek watershed after fires in 1994 and 1996. Notice that areas near ridges burned hotter while green timber was retained in moister draws. October 1996.

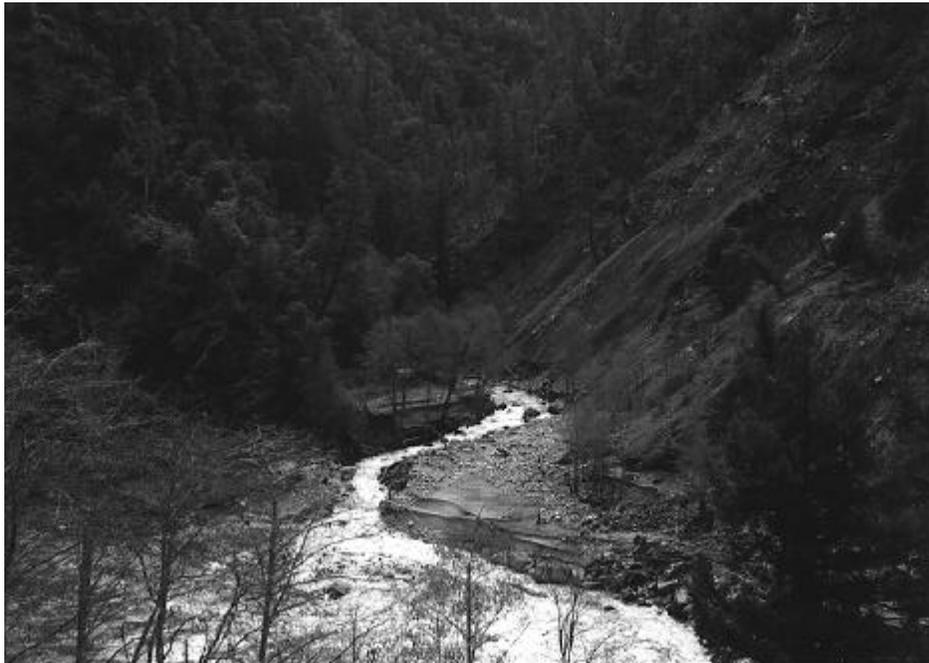
Figure A5-10. Delta at the mouth of Ukonom Creek in February 1997. Note substantial flood depositions from the January storm event.

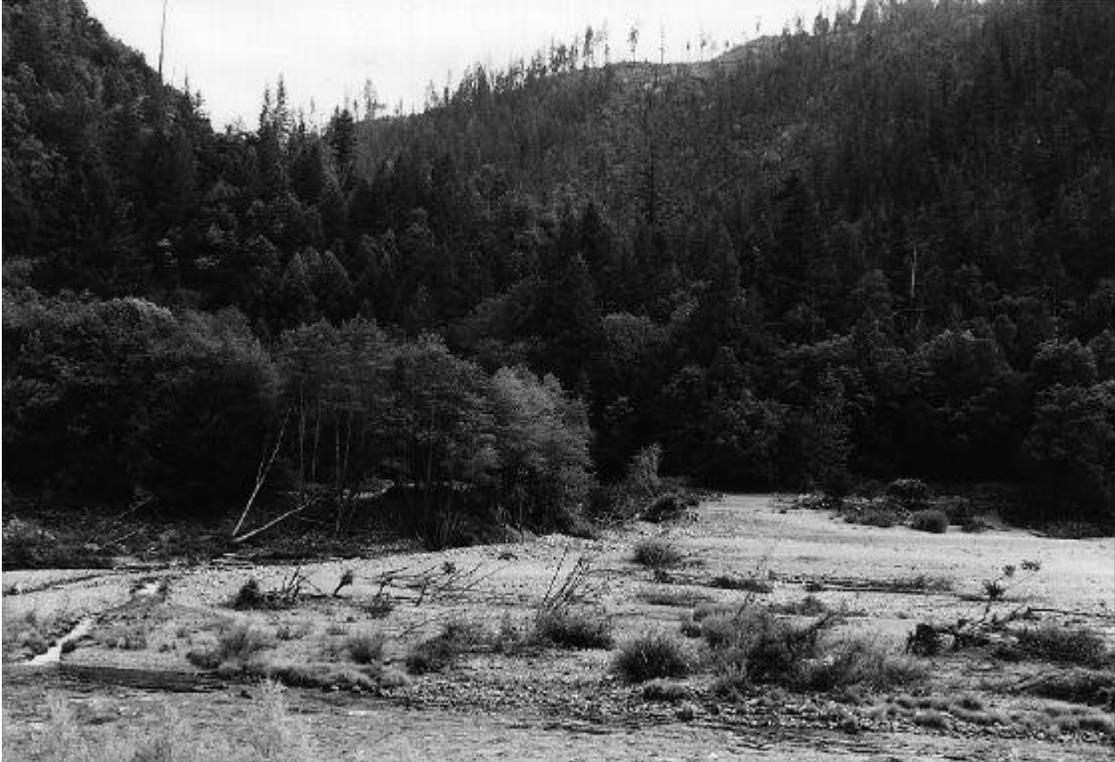
Figure A5-11. The delta at the mouth of Independence Creek in February 1997 was several hundred feet wide. Sediment in alders at center left of photo is about ten feet deep.

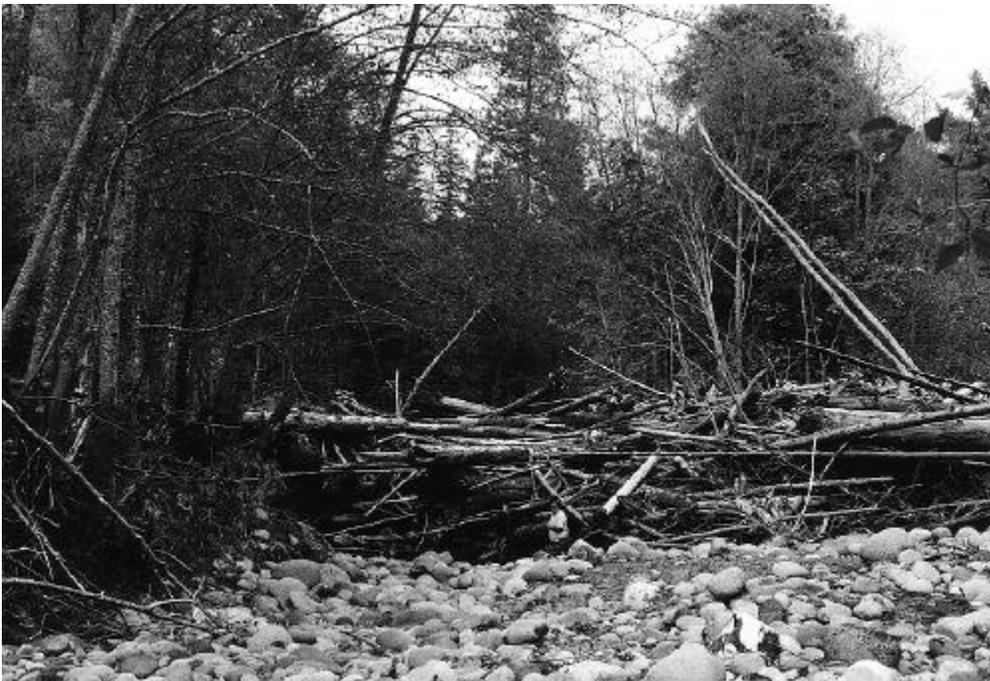
Figure A5-12. Large wood deposit in Elk Creek after January 1997 storm. USFS biologist Bill Beamis can be seen at the bottom center of the photo. September 1997.

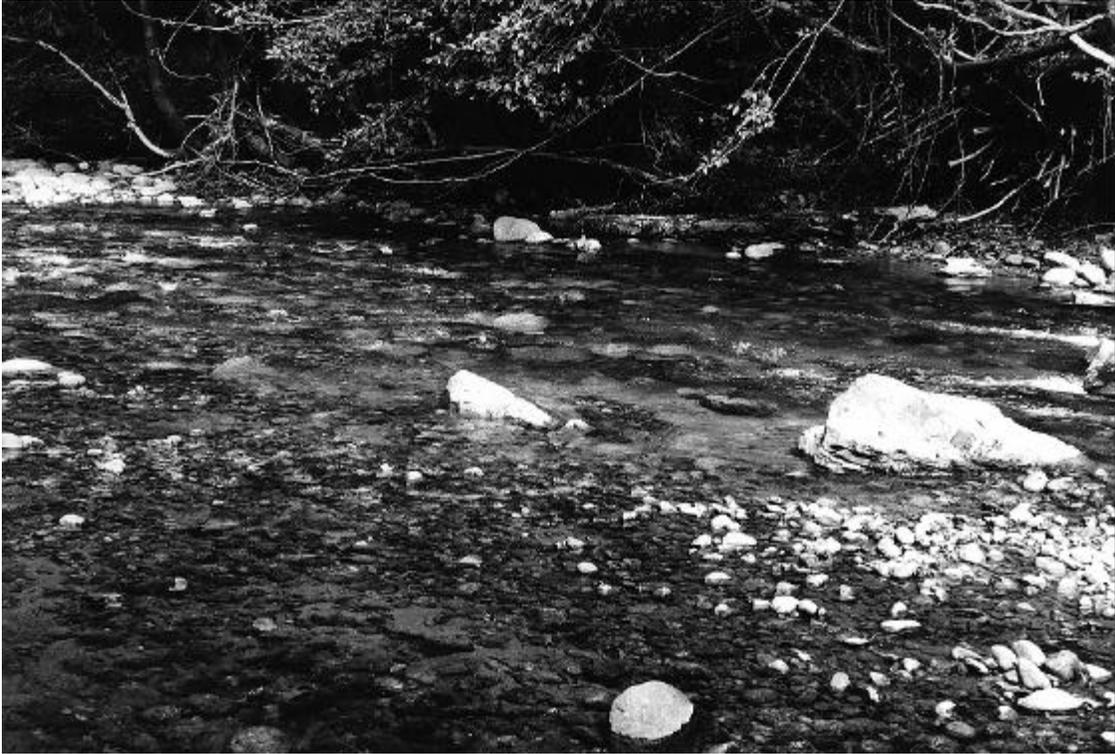
A high amount of fine sediment remained in the active channel when field visits occurred in late September 1997 (Figure A5-13). The California Department of Fish and Game measured gravel quality in Elk Creek during the summer of 1997 and found fine sediment levels less than 1 mm at 19.6% and sand size particles (<6.3 mm) at 35.2% (Jong, 1997). CDFG concluded that fine sediment levels in Elk Creek were likely to impede salmonid production. USFS temperature monitoring showed that Elk Creek had increased substantially from past years when it was almost always below 68<sup>0</sup> F, the threshold for stress for salmonids. Although the data is not yet available, the USFS characterized Elk Creek as having a serious water temperature problem in 1997 (De La Fuente, 1998).

Figure A5-13. Partially buried boulder cluster on Elk Creek, September 1997. Note the lighter colored fine sediment in the active channel behind boulders.

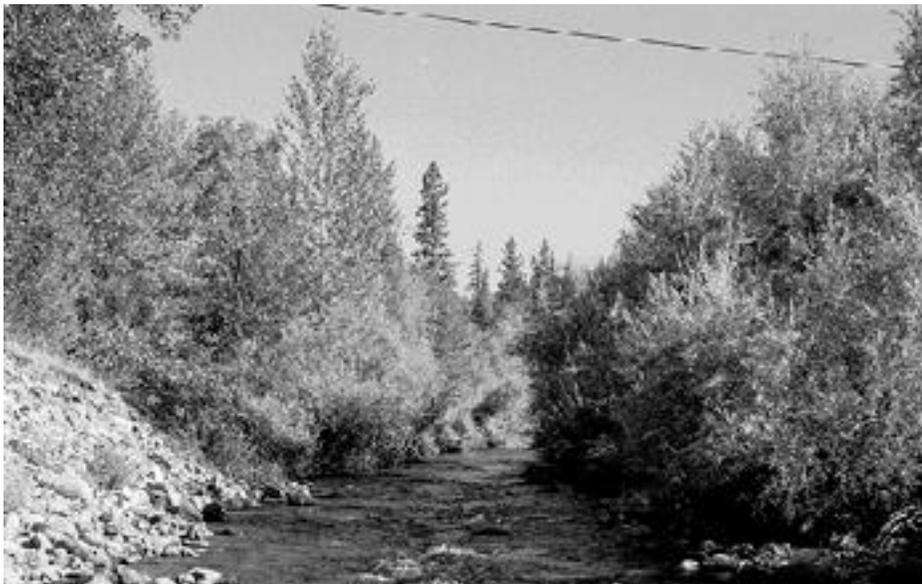
Figure A5-16. Lower Beaver Creek in July 1997 after high flows earlier in the year had washed out boulder weirs.

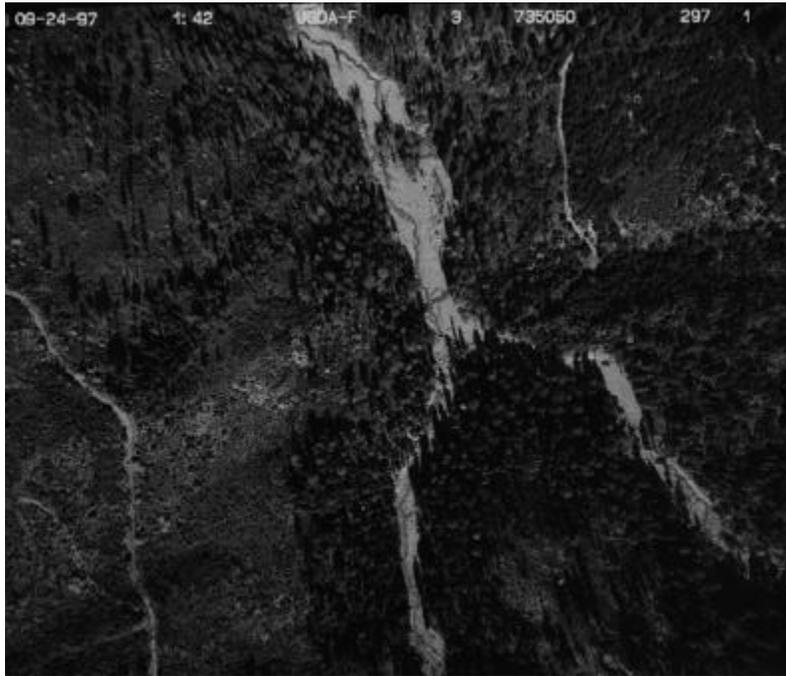
active landslides in this relatively small watershed. Walker Creek also had extensive areas of its watershed burned in the 1987 fires. One reach of Walker Creek went from approximately 50 feet wide to over 200 feet wide (Figure A5-17). It will be decades before this tributary recovers. It had provided a medium sized refuge area of cold water at its convergence with the Klamath according to Belchik (1997), but stream temperatures are likely to have risen substantially as a result of flood damage.

Figure A5-17. Mid-reach of Walker Creek where convergent debris torrents caused the channel to widen to 200 feet during the January 1997 storm. Photo courtesy of Klamath National Forest and Redwood Sciences Lab, Arcata.

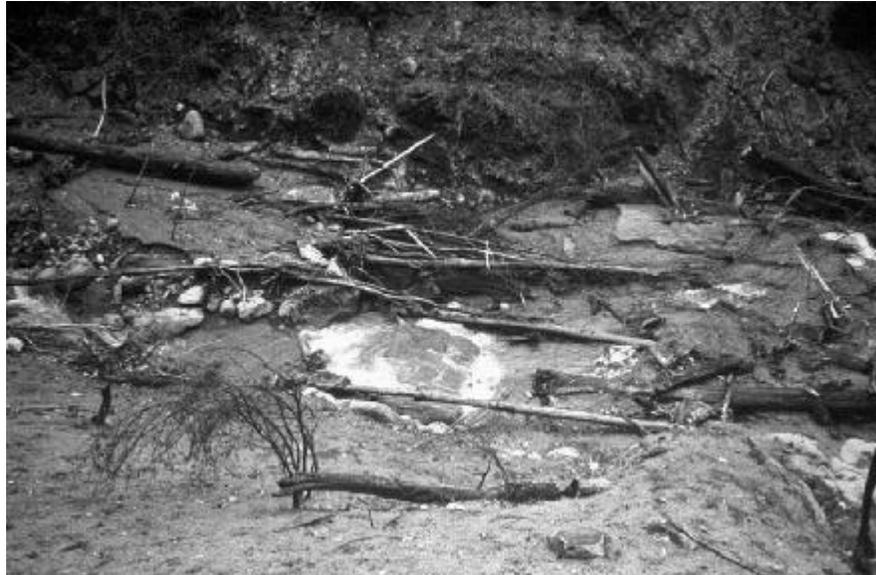
high amounts immediately after the 1987 fires (Figure A5-21). An estimated 105,100 cubic yards of sediment entered the Salmon River immediately following the 1987 fires as a result of surface erosion, increasing from 15,800 cubic yards prior to the fire (De La Fuente and Haessig, 1994). Lisle (personal communication) noted high amounts of sand in main channel reaches in years following the fire, but flushing flows in 1992-93 reduced storage in these areas. Because rainfall was extremely low until 1992-93, much less surface erosion occurred than if intense rain had followed the 1987 fires more closely.

Figure A5-21. Olsen Creek in the Salmon River Basin with decomposed granitic sand in channel after the 1987 fires and moderate rainfall. Photo courtesy Andy Collonna.

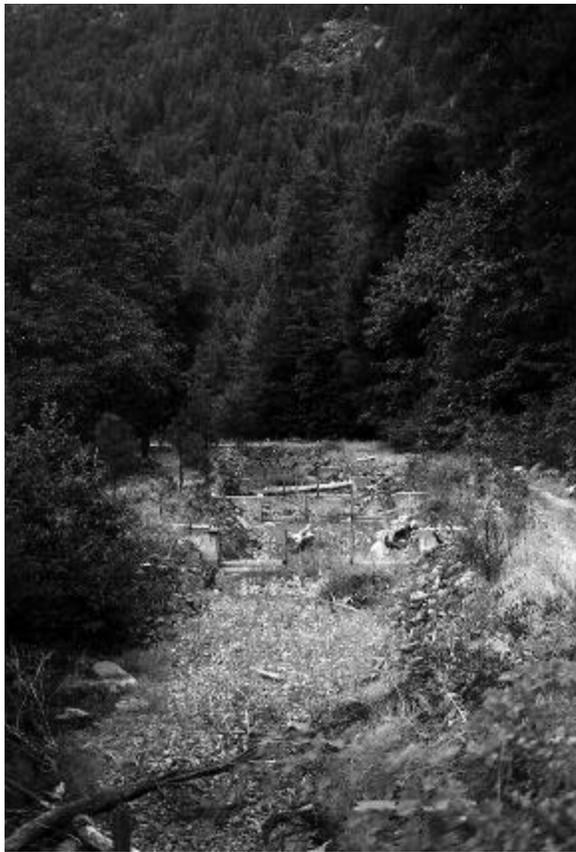
Figure A5-25. Kelsey Creek spawning channel de-watered by flood effects. Photo taken July 1997.

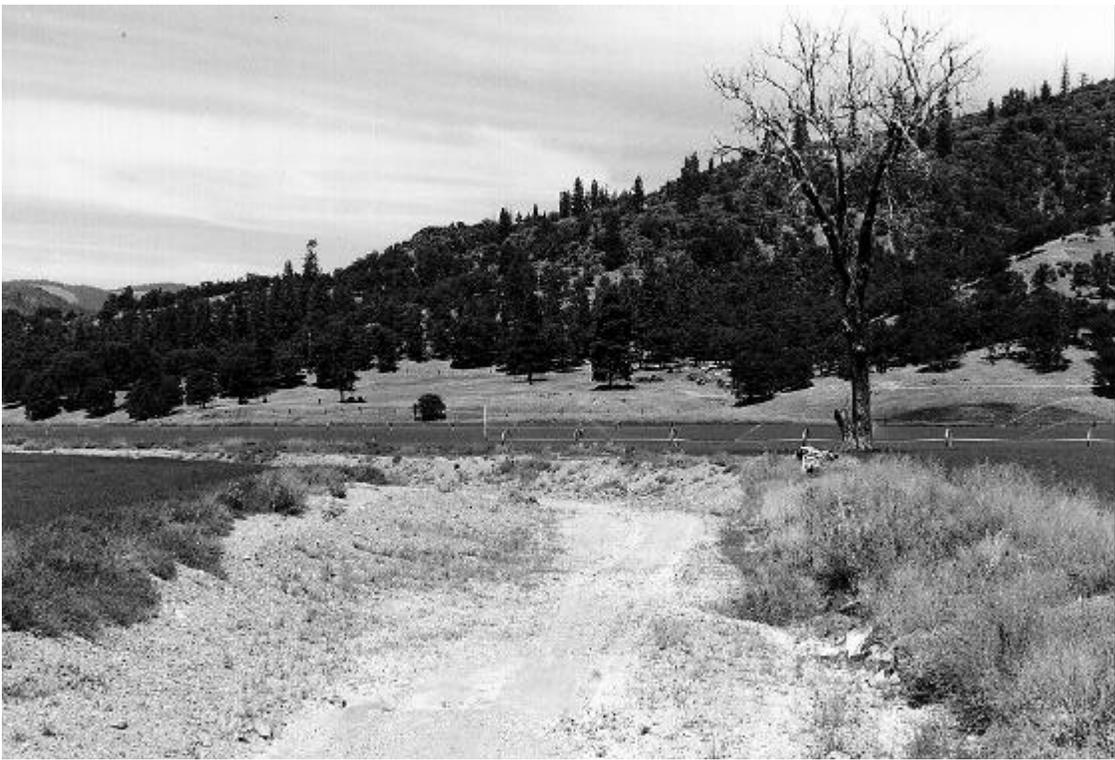
Moffett Creek has been noted to have major erosion problems in recent years (Figure A5-27). Even during moderate flows, Moffett Creek has such high turbidity levels that it discolors the Scott River down to its convergence with the Klamath. This stream as well as the East Fork Scott and Schackleford Creek experienced bank erosion during the January 1997.

Figure A5-27. Moffett Creek channel during summer 1997. Riparian vegetation in Moffett Creek has decreased, most likely as a result of a drop in the water table.

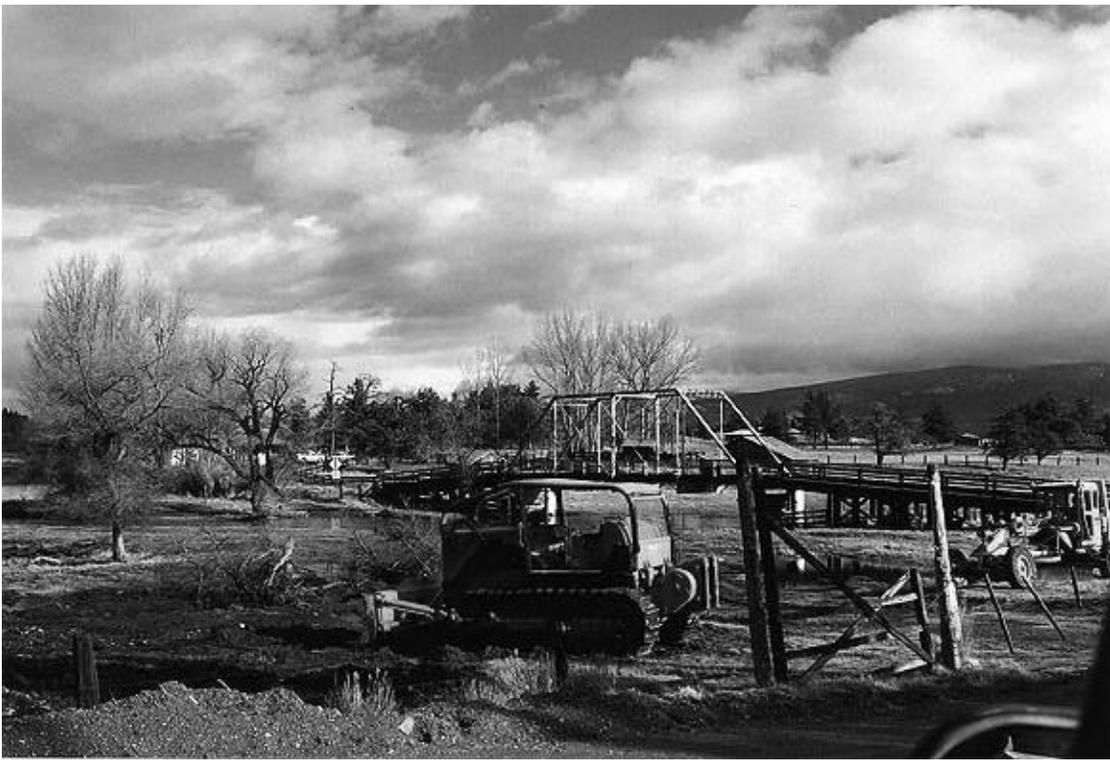
Figure A5-45. Riparian zone of the Shasta River at Louie Road with heavy equipment and filled riparian wetlands.

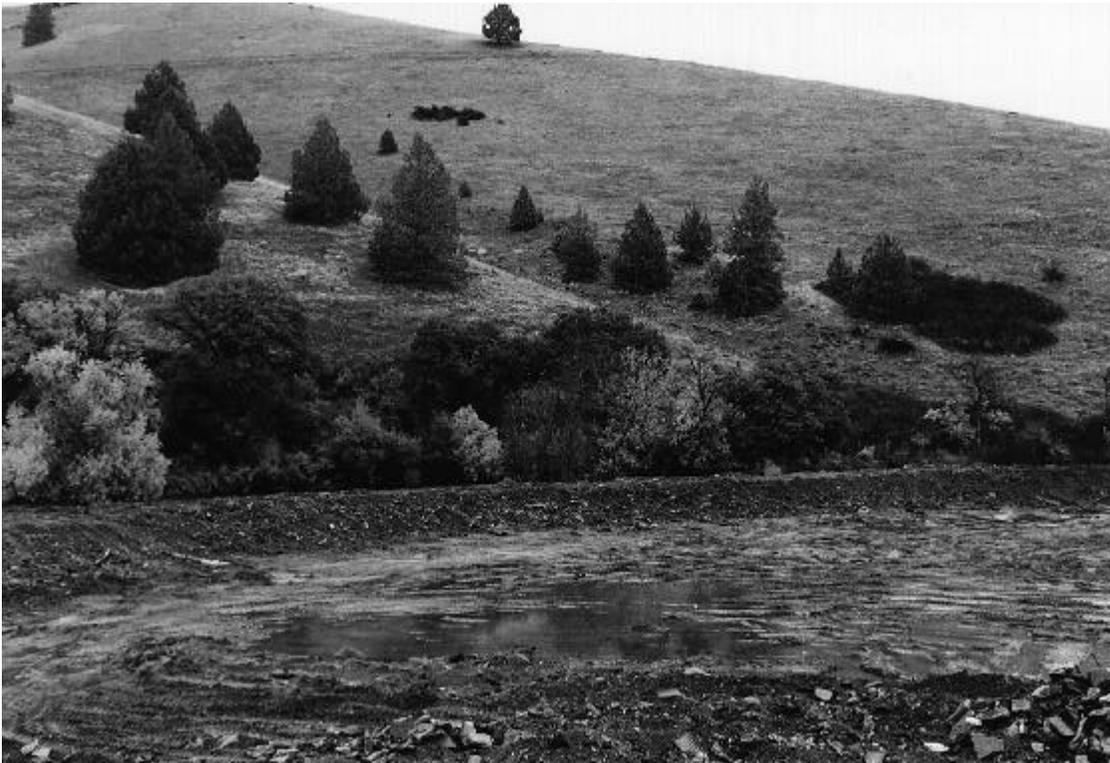
Figure A5-46. Riparian destruction along the Shasta River at Highway 263. Berm at the center of the photo confines the Shasta River to a narrow channel against far bank. Note wetland area in foreground. Photo October 1997.

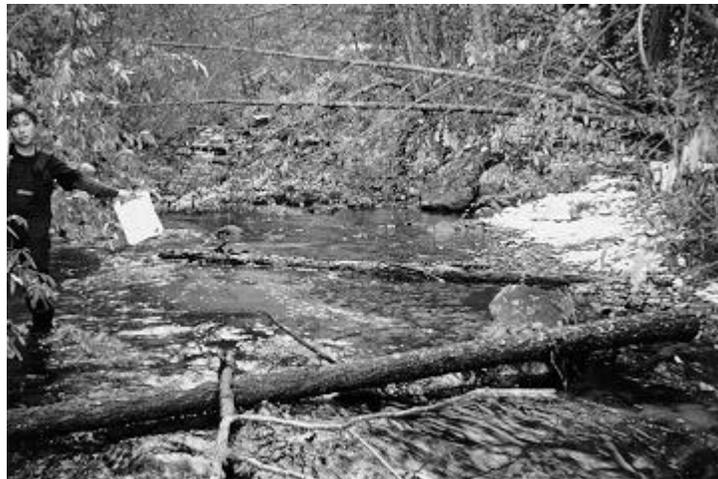
Figure A5-52. Klamath National Forest photo-point taken in 1994 of in-stream cover logs installed in 1992. The wood in this project was not sufficiently large to withstand high flows.

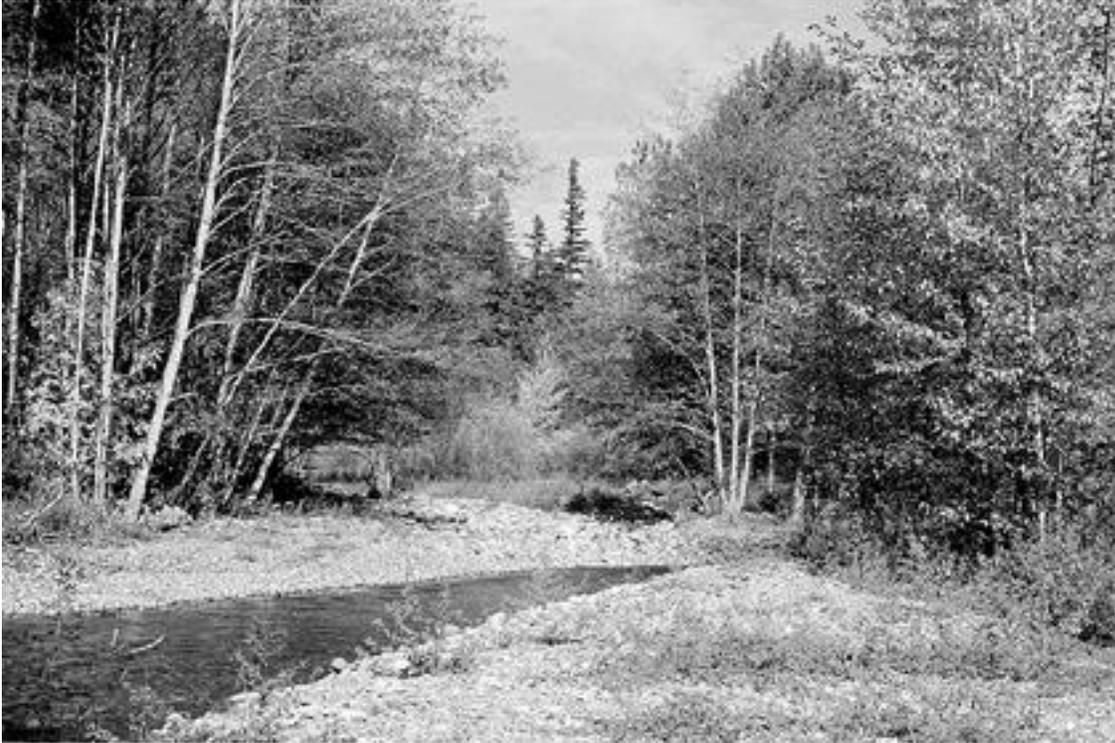
Figure A5-53. This reach of Indian Creek at RM 8.9 was treated with boulder clusters that were buried by the January 1997 storm event. Aggradation at this site must have been at least four feet.

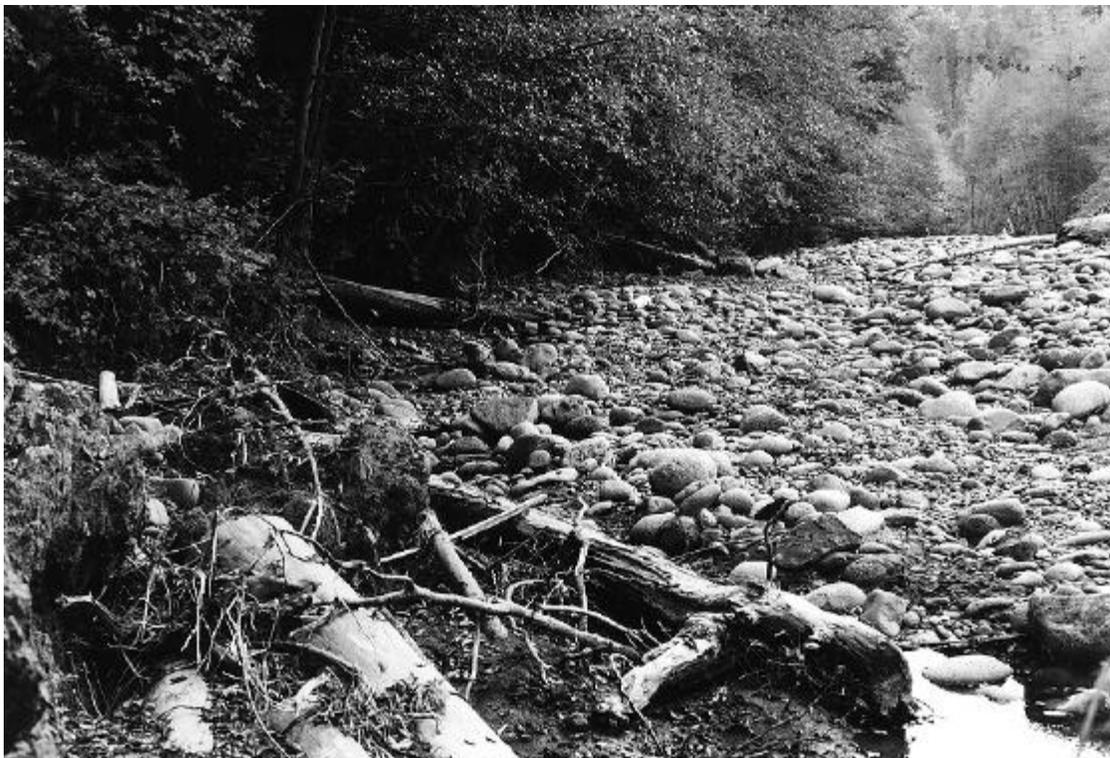
Figure A5-56. Elk Creek side channel after January 1997 flood with log cover structures isolated from the main flow by shifting bedload.
