# **Ah Pah Creek Fish Passage and Habitat Improvement Project**

## **Final Report**

**Ah Pah Creek Fish Passage and Habitat Improvement Project**  
**USFWS Agreement #14-48-11333-8-J113**  
**Project #98-HR-07**

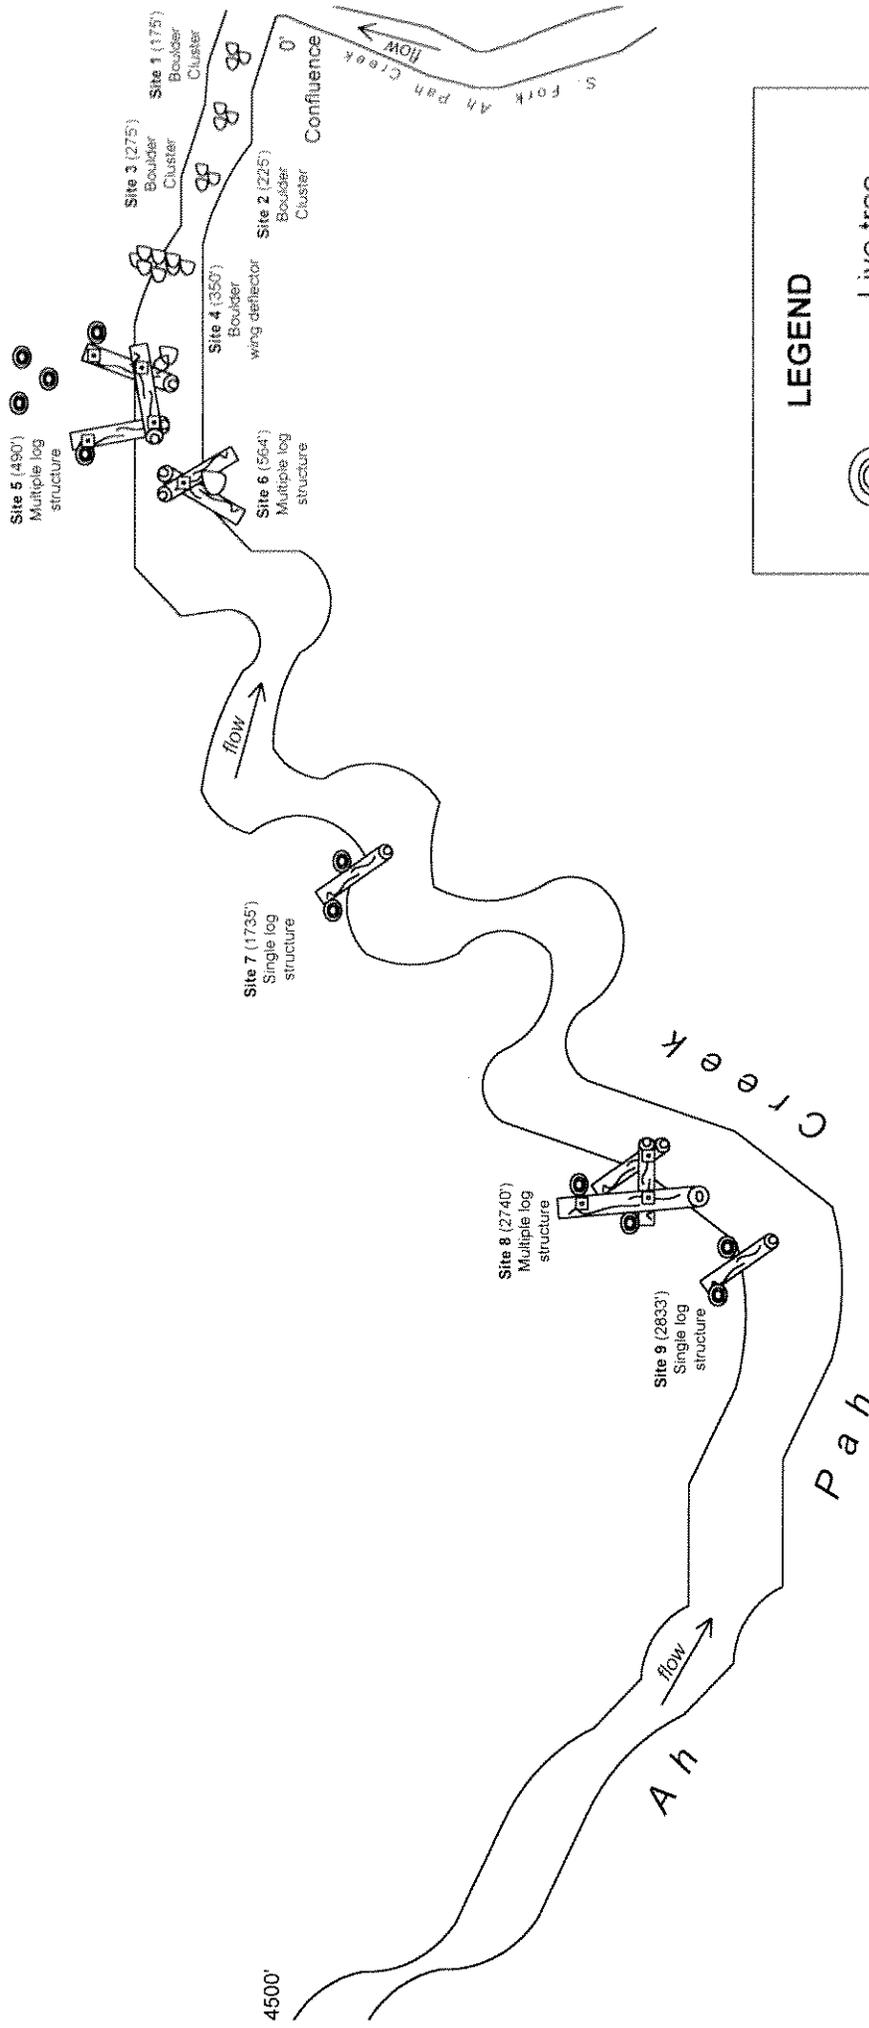
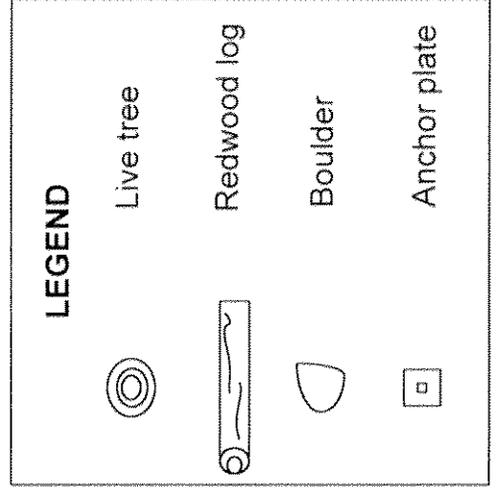
A great deal of time and effort was expended developing, designing, and implementing the Ah Pah Creek Fish Passage and Habitat Improvement Project. Development and design of the project were conducted by a team of CCC and DFG personnel. Several different CCC crews of up to fifteen individuals contributed to the implementation of the enhancement measures. Work was done in the summer during low flow conditions and outside of endangered species restrictions. A total of fifteen enhancement sites were completed in the summer of 1998 (see site diagram).

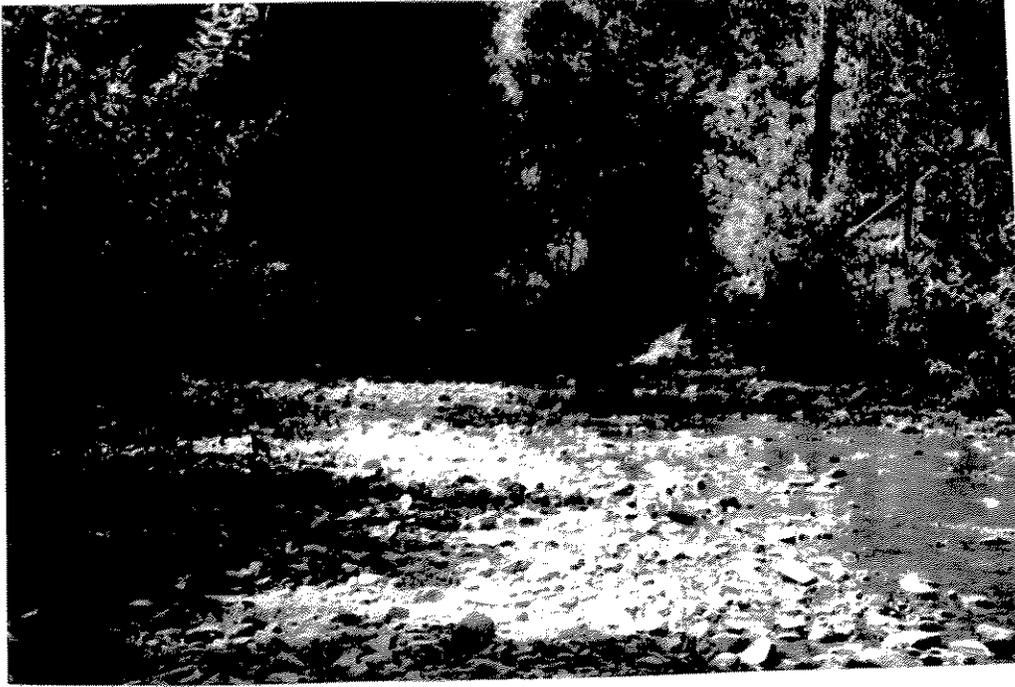
**Before:** Boulder Cluster site (175', 225', and 275'). Shallow and featureless riffle along lower Ah Pah Creek lacks any sort of instream cover, pool depth, or habitat complexity.

Boulder cluster and deflector work took place in the bottom 400 feet of the project area. Boulders utilized for these sites were left over from a channel reconstruction project located immediately downstream. Boulder clusters were placed in a straight and featureless reach of Ah Pah Creek (see site 175' photo). Each cluster consisted of three boulders spaced approximately two feet apart, in a triangular formation. The sets of clusters were placed mid channel, fifty feet from one another and slightly off set. Boulders used weighed approximately one to two tons each, and were roughly three to five feet in diameter. The boulder deflector placed instream was located just above the boulder cluster reach (see site 350' photo). The deflector was designed to concentrate flow against a bedrock wall and thus increase pool depth. Approximately fifteen boulders were put into this structure. All boulders were placed by hand crews using griphoists. Many of these boulders had to be moved more than two hundred yards to their current locations.

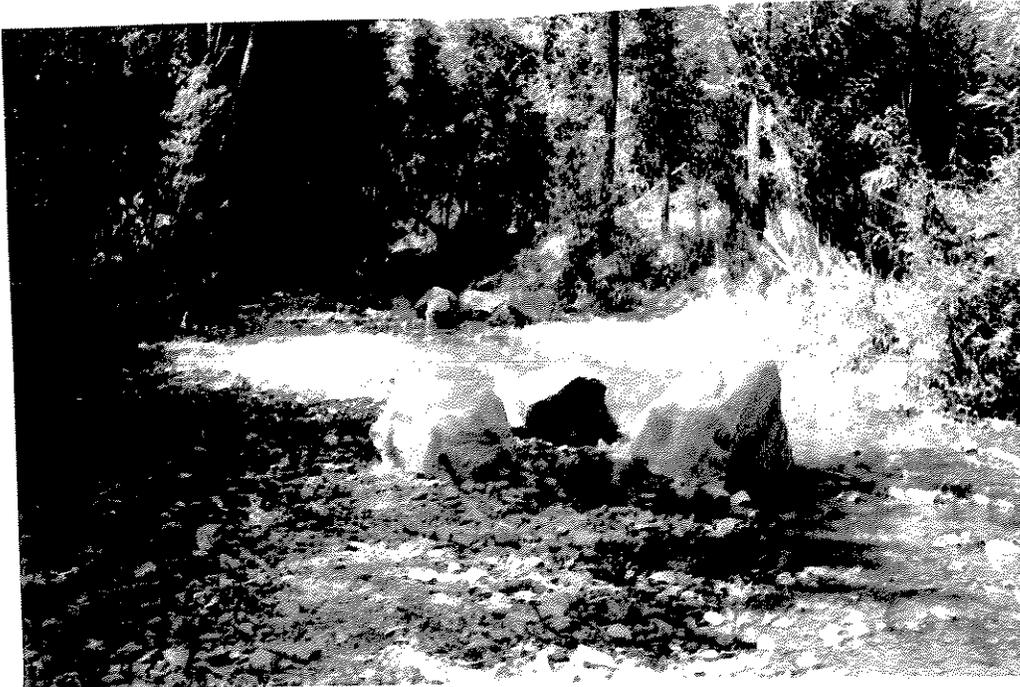
**After:** Boulder cluster sites placed in riffle to break up a monotypic reach of creek. Two winters later, the sites have helped enhance stream depth and habitat.

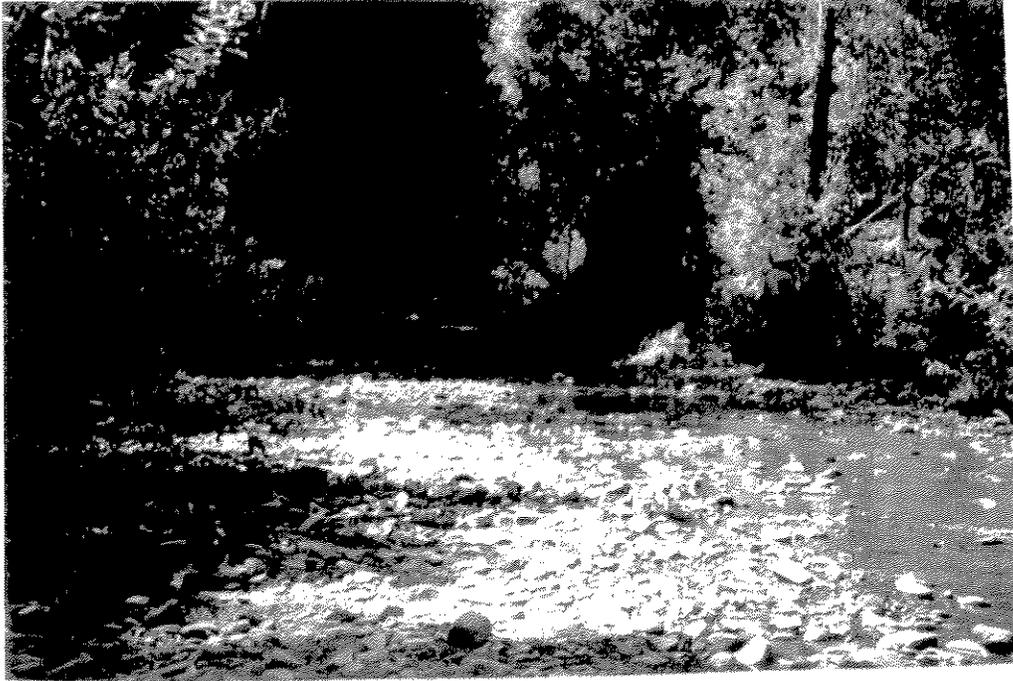
**Before:** Boulder Cluster site (175', 225', and 275'). Shallow and featureless riffle along lower Ah Pah Creek lacks any sort of instream cover, pool depth, or habitat complexity.

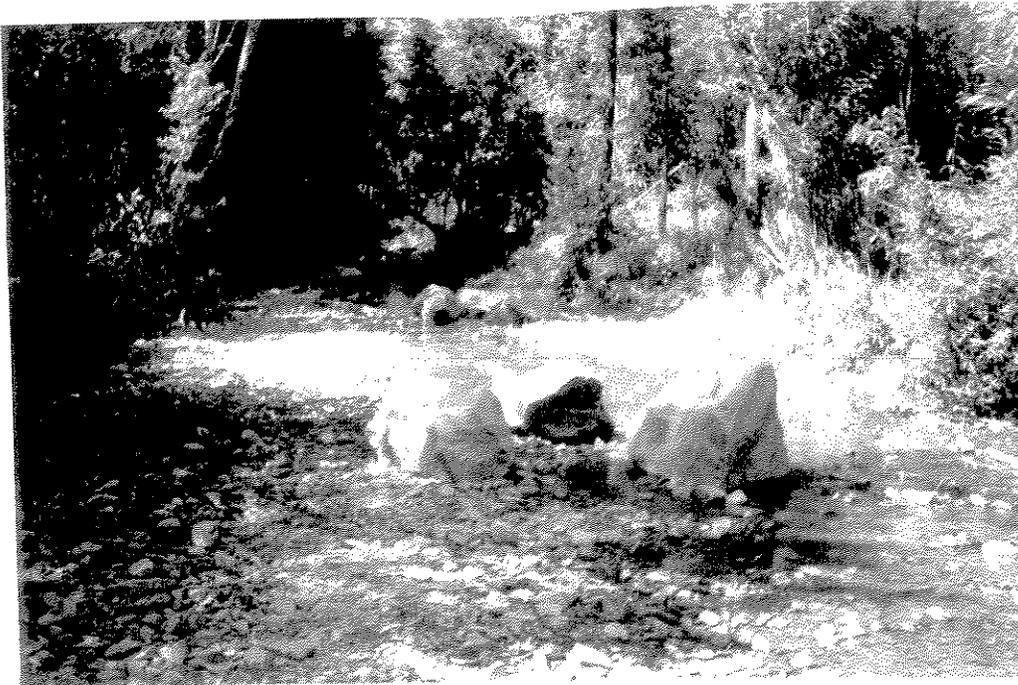
**After:** Boulder cluster sites placed in riffle to break up a monotypic reach of creek. Two winters later, the sites have helped enhance stream depth and habitat.

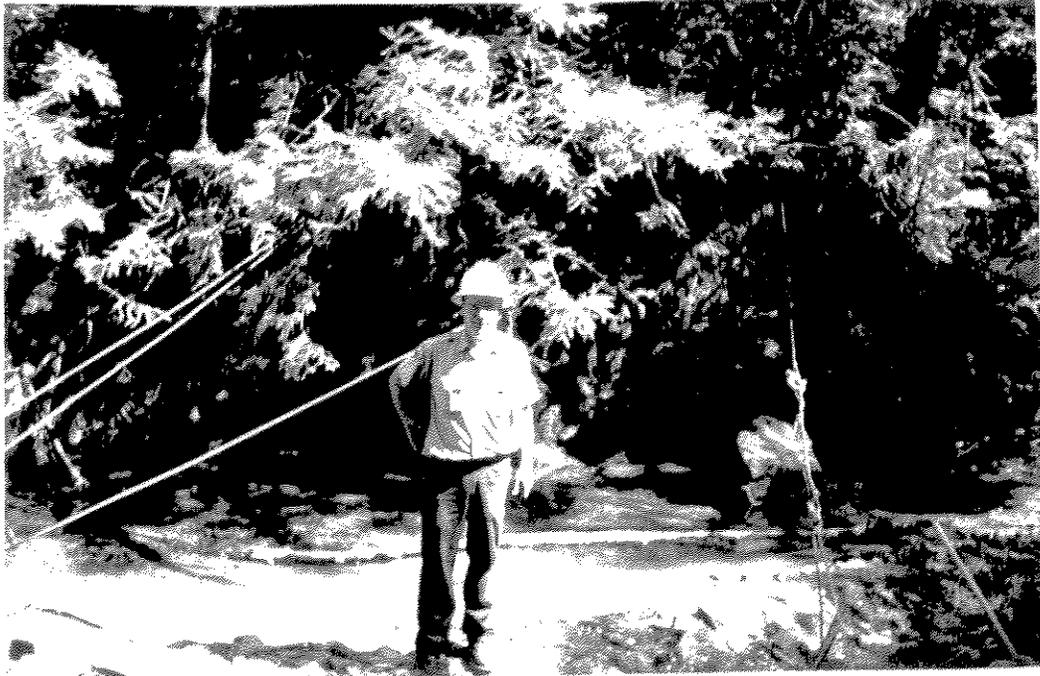
**Before:** Multiple Log Cover Structure site (490'). A shallow pool and associated rootwad provided the perfect opportunity for instream enhancement. Overhead canopy cover was adequate, but instream habitat was non-existent.

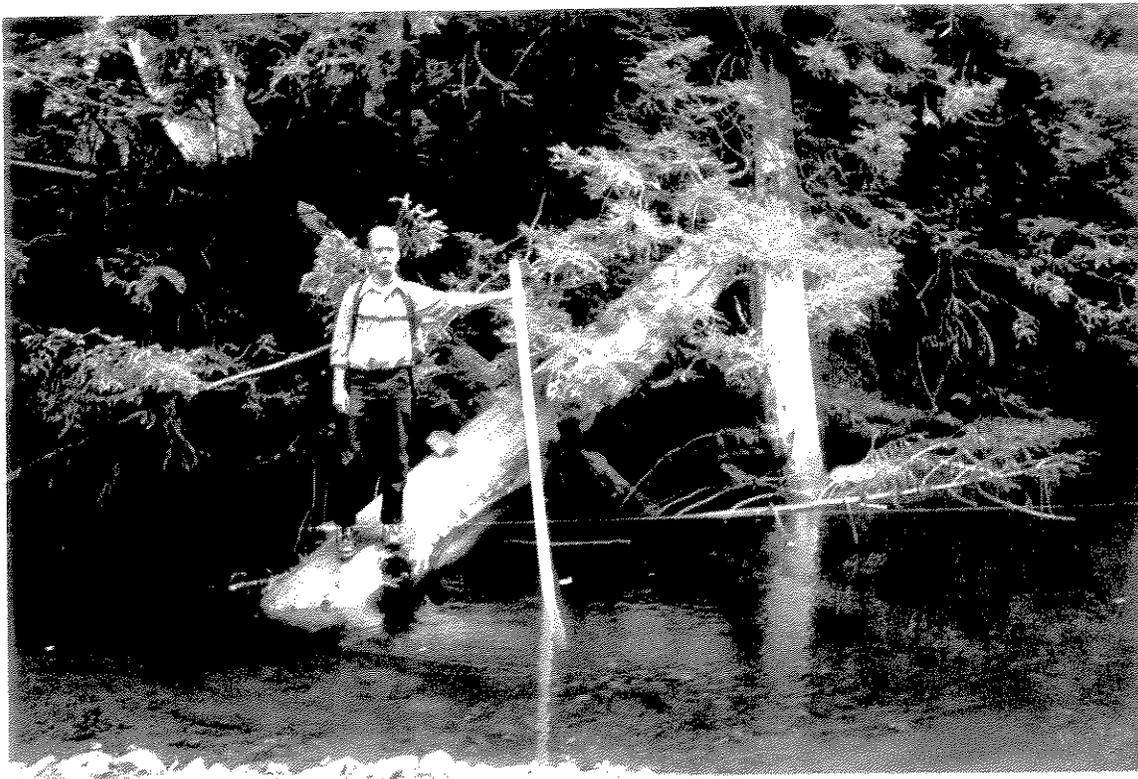
**After:** Three logs and two boulders added to the pool increased depth by two feet, expanded pool volume by at least 50%, and helped collect woody debris. At least twenty juvenile salmonids were observed utilizing the log enhanced pool. Prior to enhancement, no more than five fish would be seen at the site at any one time.

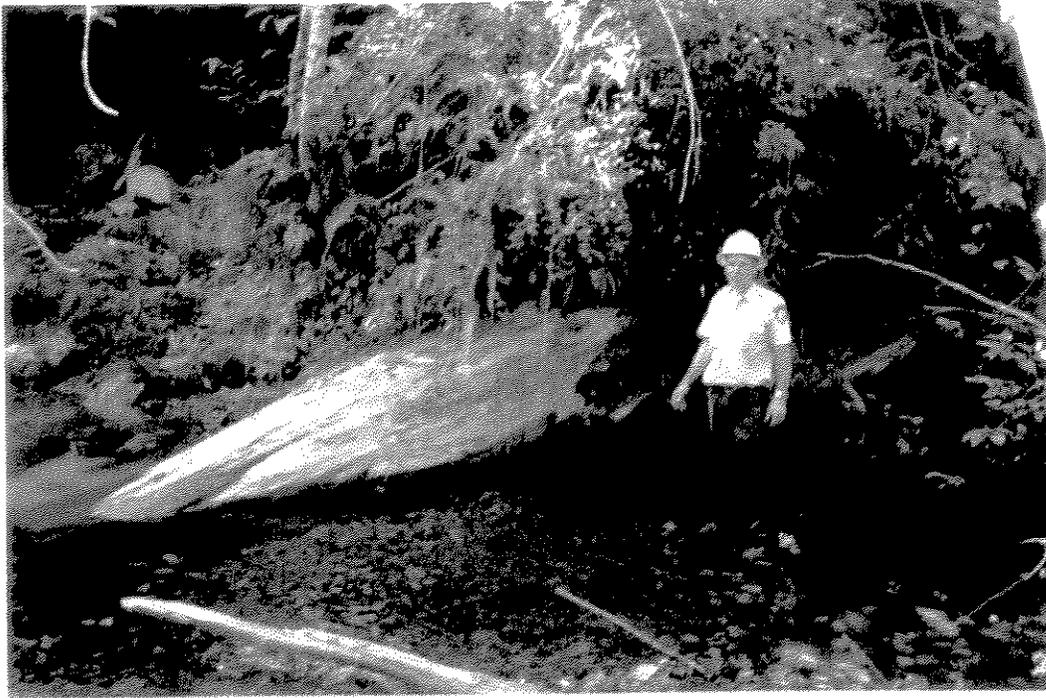
**Before:** Digger Log enhancement site (564'). Large downed log helped scour a shallow pool, but little instream cover exists.

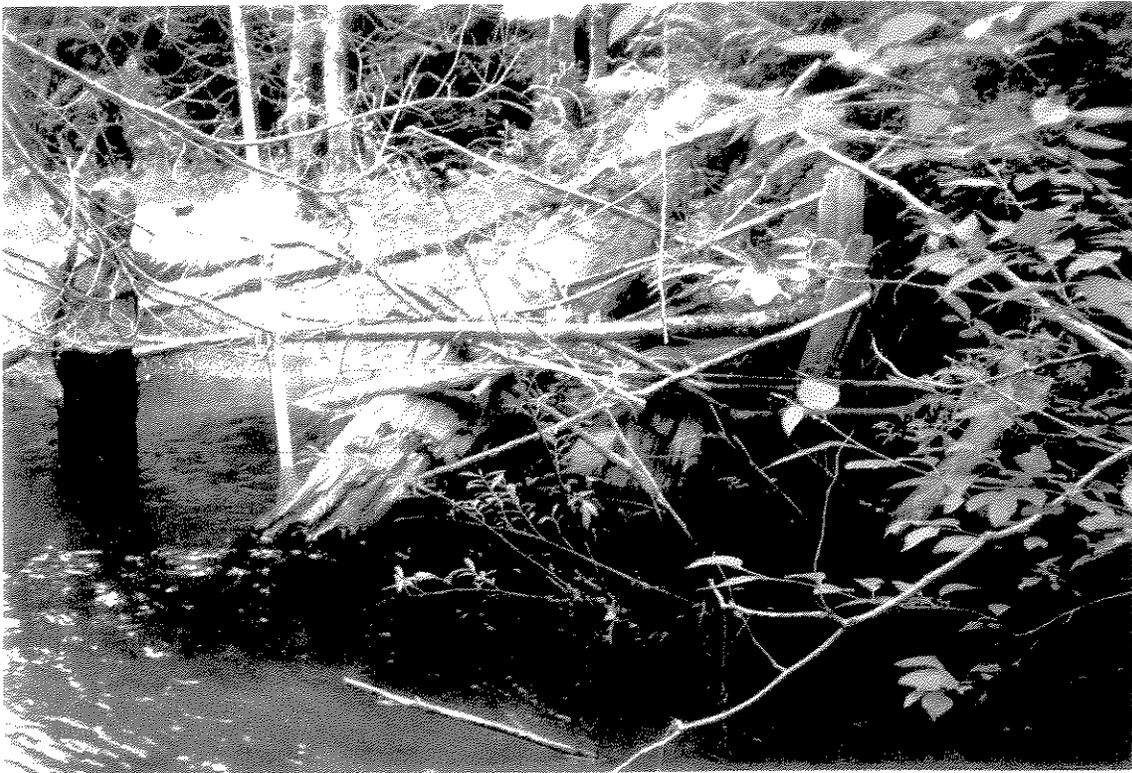
**After:** Log structure collected a large amount of woody debris after one winter season. Not only did cover improve dramatically, but pool depth was greatly enhanced.

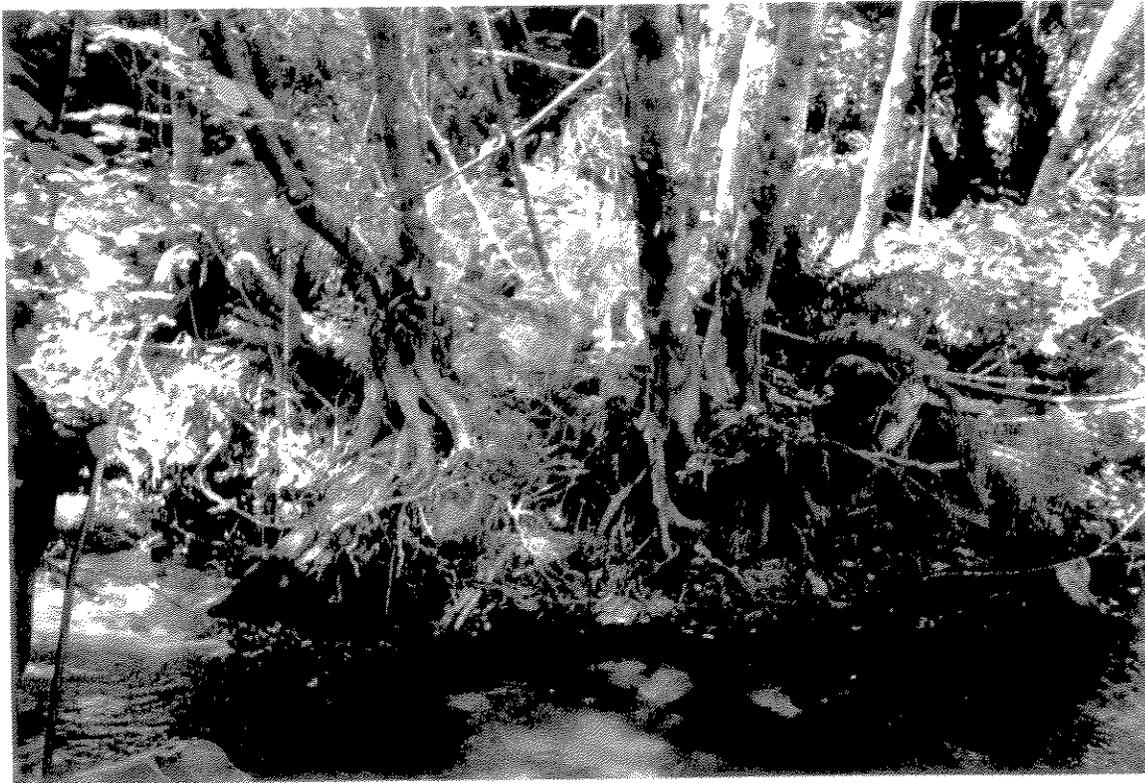
**Before:** Multiple Log Structure site (2,740'). Enhancement site lacked any instream fish habitat prior to log placement.

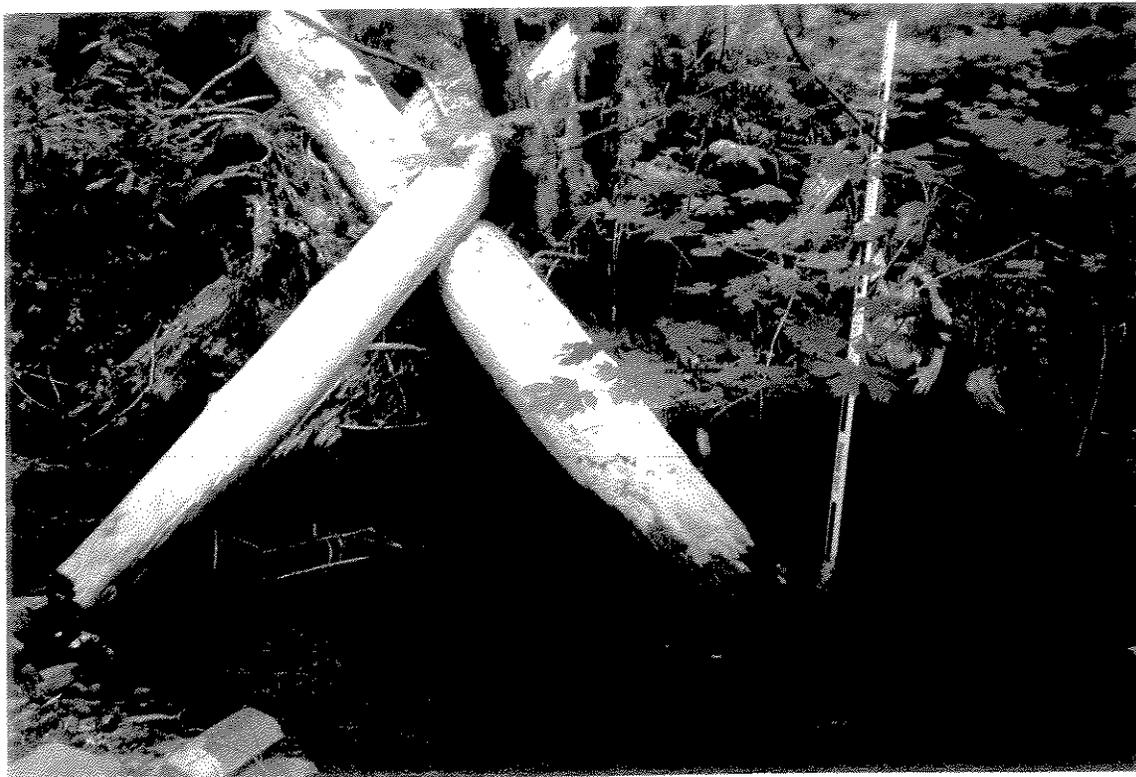
**After:** Recently completed log cover structure. Redwood logs will provide escape cover for juvenile fish and help deepen this rootwad formed pool.

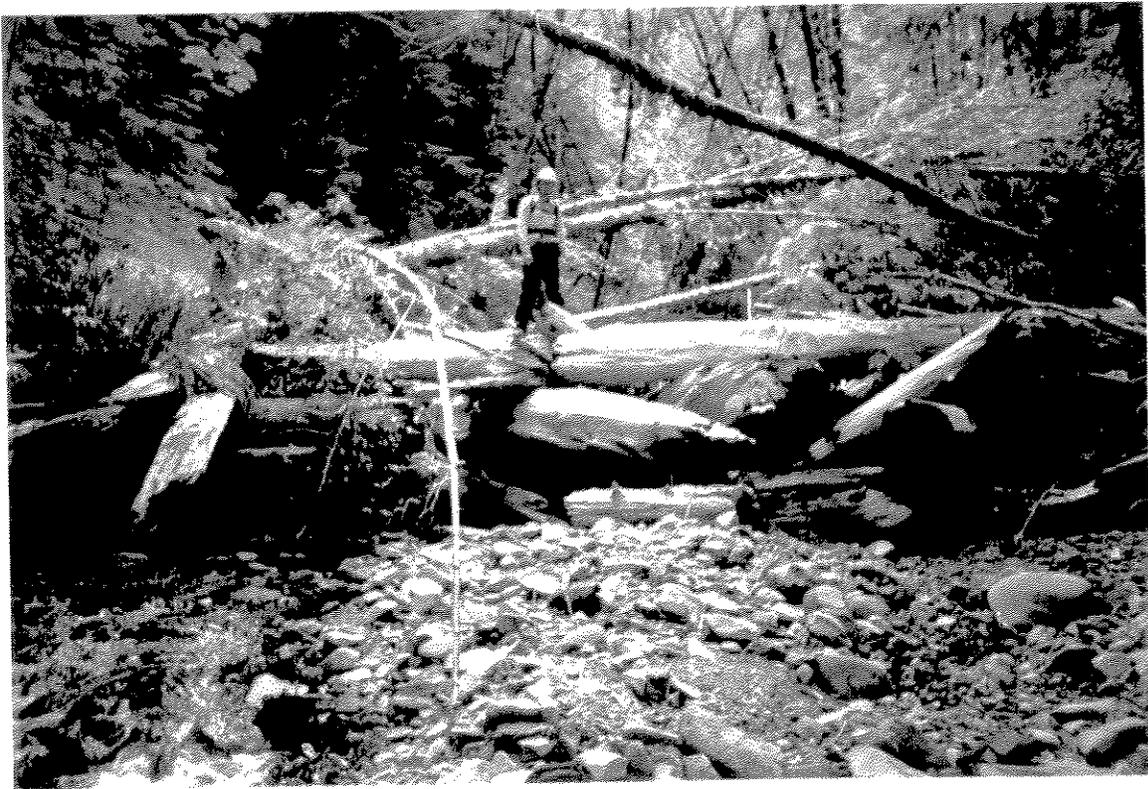
**Before:** Barrier modification site (10,900'). Accumulation of large and small woody debris was determined to be a partial barrier to adult fish migration during low flows.

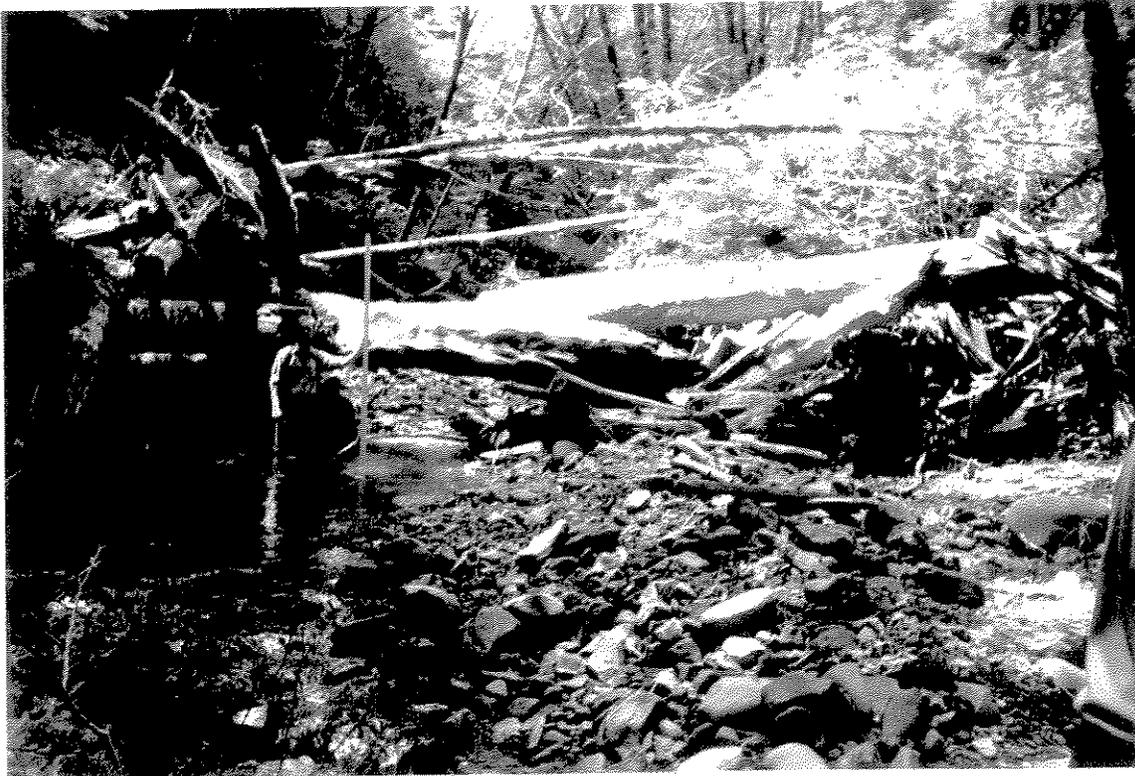
**After:** Barrier modification after winter flows. A small six foot hole was cut out of the debris jam to allow fish access to high quality habitat upstream of site. The majority of the LWD was left in place to provide excellent rearing cover for salmon and steelhead.
