# Appendix 5: Habitat Trends and Restoration

## 1986-1997

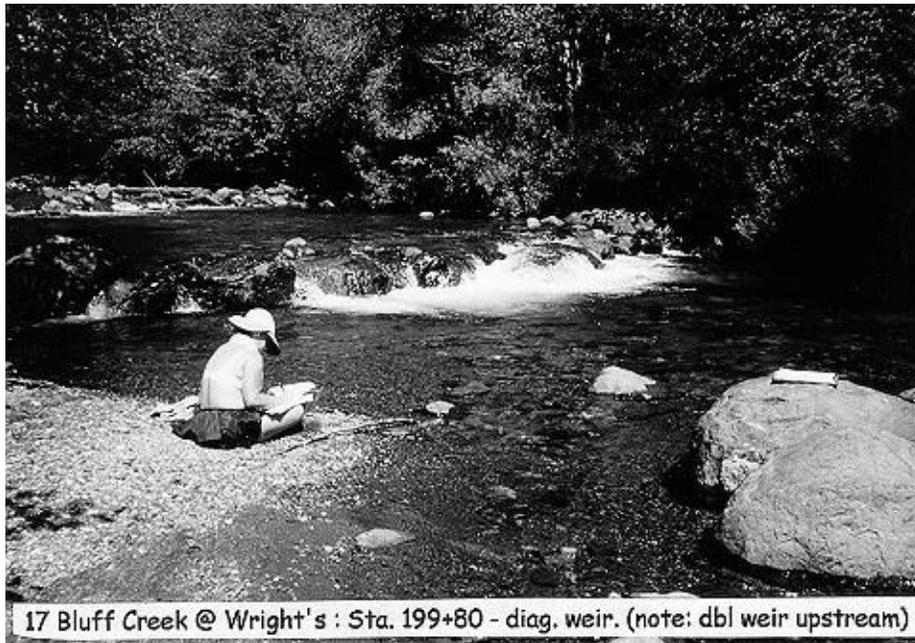
Figure A5-7. Boulder weir on Bluff Creek in September 1997. Photo courtesy of Six Rivers National Forest.

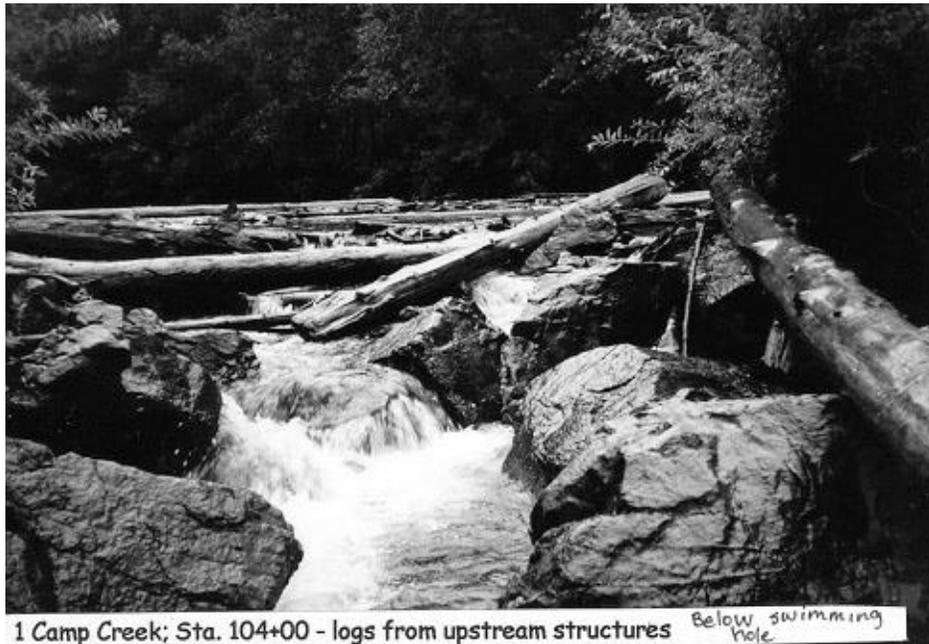
Figure A5-8. Camp Creek boulder weir with large wood above delivered by the January 1997 storm. Photo courtesy of Six Rivers National Forest.

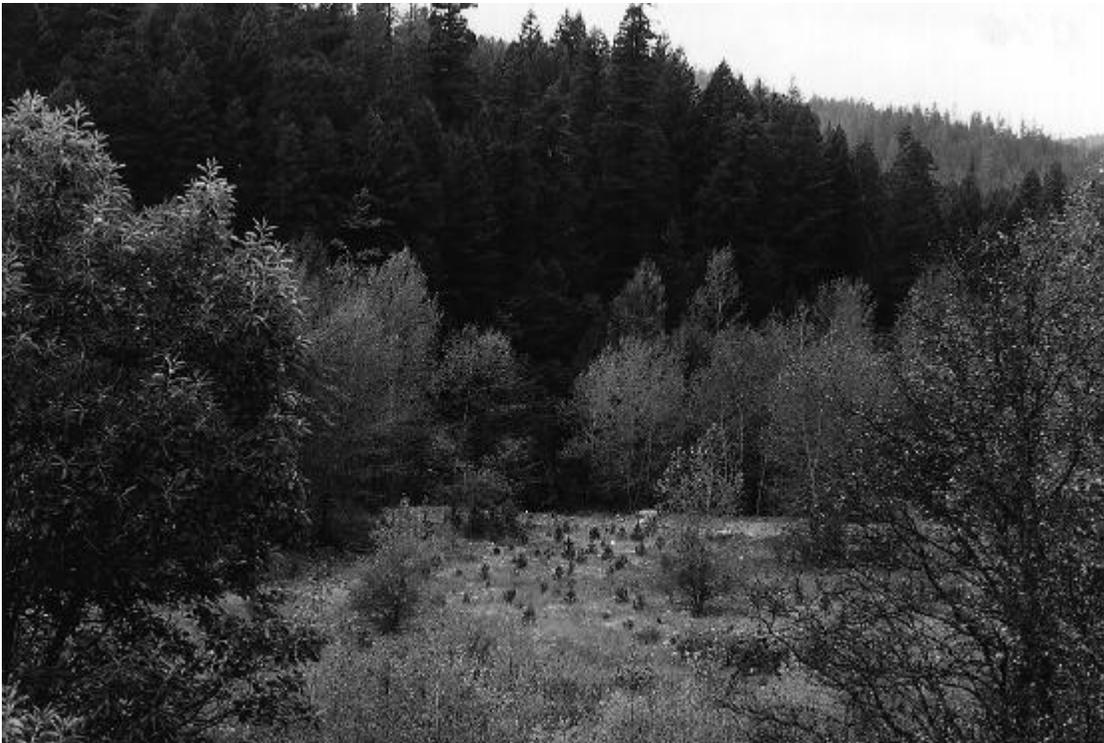
Figure A5-14. Indian Creek flood plain with conifers planted by the U.S. Forest Service to help restore riparian over-story. September 1997.

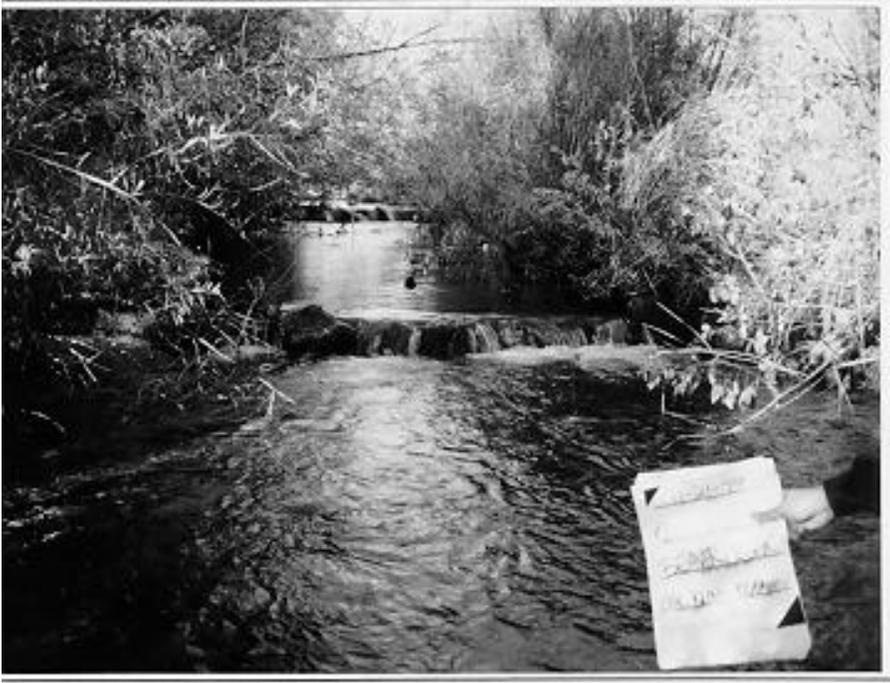
Figure A5-15. Boulder weirs in lower Beaver Creek in fall 1994. Notice encroaching riparian. Photo courtesy Klamath National Forest.

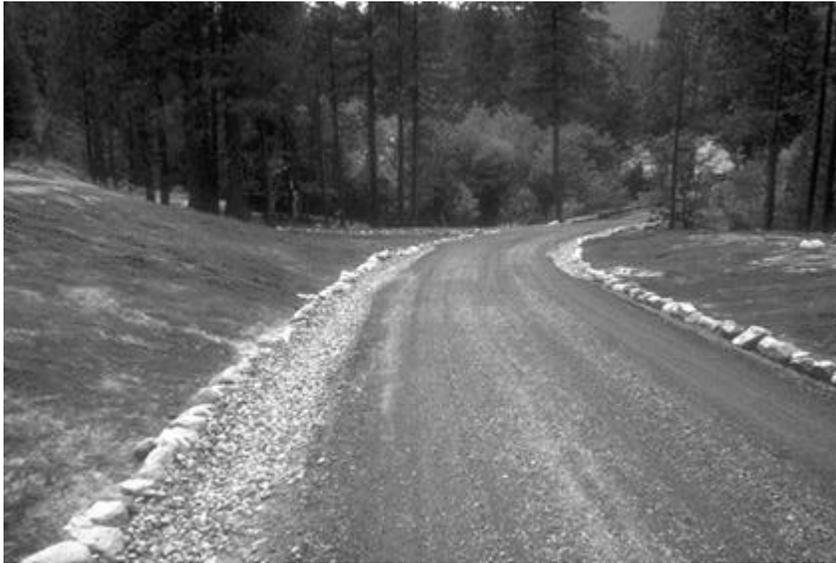
Figure A5-23. Road in French Creek drainage that has been rocked to prevent sheet erosion. Photo courtesy Scott CRMP.

Following the sediment study, a French Creek Watershed Advisory Group was formed to help coordinate activities in this a highly erodible Scott River sub-basin. The U.S. Forest Service, private timber landowners, ranchers, the County of Siskiyou and the Scott Valley CRMP all contributed to erosion control projects in French Creek (Figure A5-23). Studies to determine fine sediment in pools ( $V^*$ ) were conducted by the U.S. Forest Service in French Creek to determine the progress of restoration. The volume of fine sediment in pools decreased from approximately 30% in 1992 to nearer 10% in the following three years (Figure A5-24). It is possible that erosion control efforts in the French Creek watershed have contributed to the decrease in fine sediment. However, further work is needed with regard to sediment stored on terraces in French Creek before there is definitive proof that the net sediment yield from the basin is decreasing.

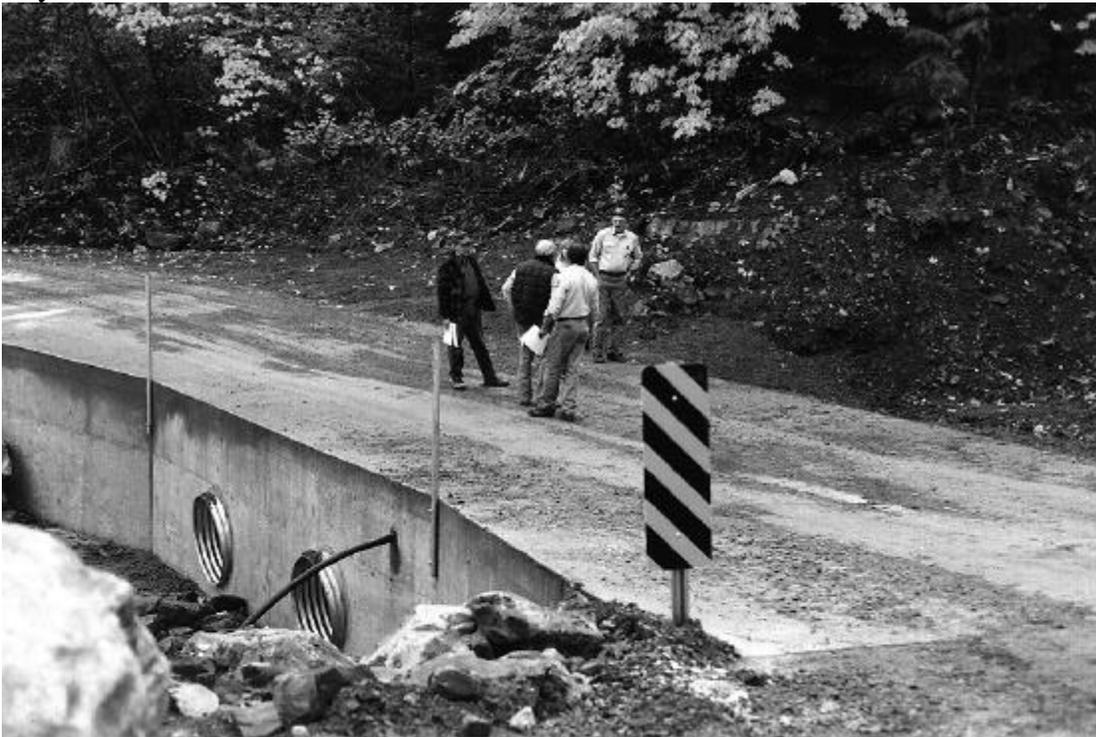
Figure A5-26. New cement ford on Kelsey Creek installed by Klamath National Forest with flood relief money. This approach should reduce long term maintenance and prevent sediment input into Kelsey Creek. October 1997.

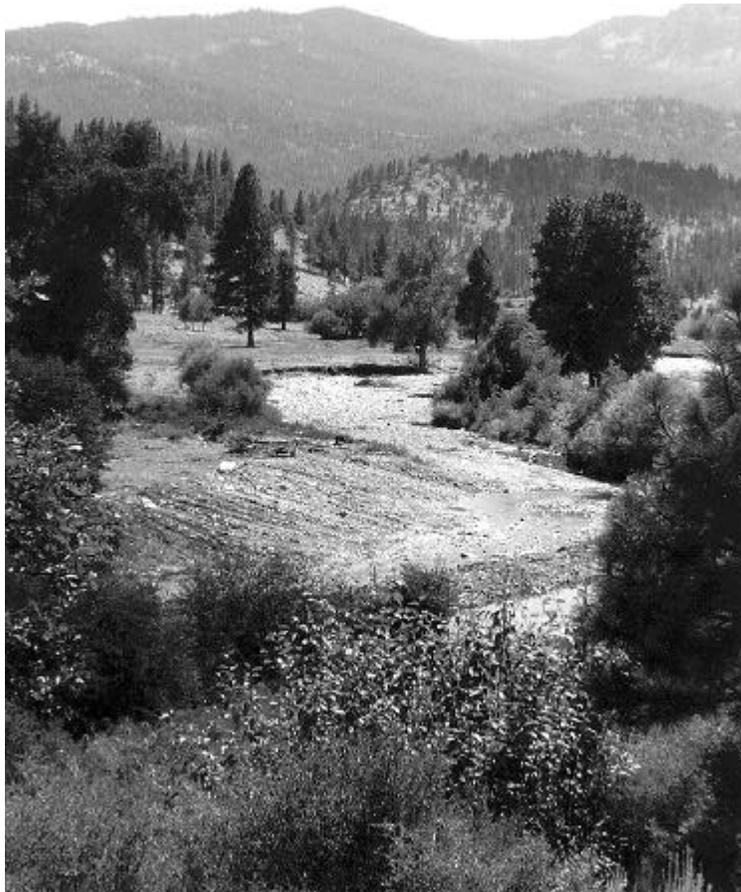
Figure A5-28. East Fork Scott River after excavation with heavy equipment under emergency flood relief. July 1997.

Subsequently, NRCS funded emergency manipulation of the channel with heavy equipment (Figure A5-28). While bulldozing bedload to form a berm increased channel capacity temporarily, this action does not promote long-term channel stability and riparian restoration. Therefore, such activities lead to chronic problems with bank erosion. Removing large wood during these activities also decreases fish habitat complexity.

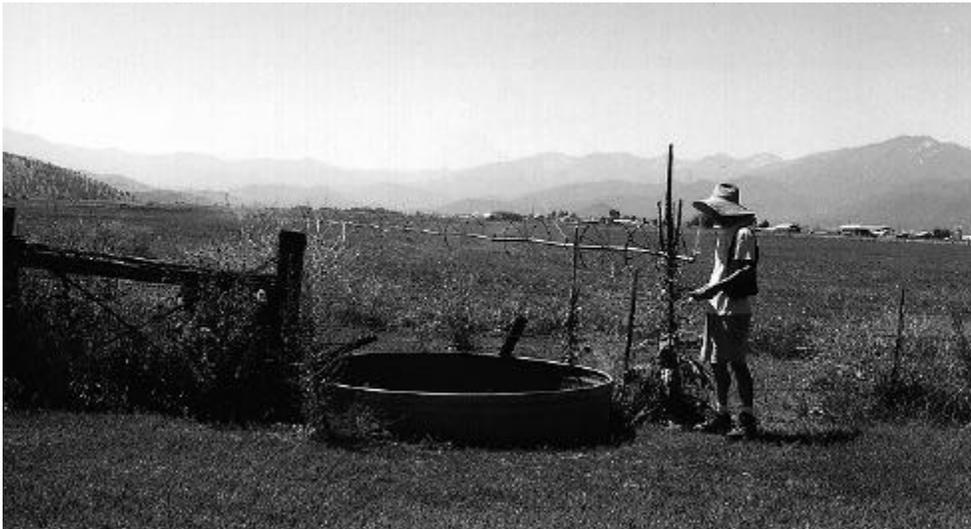
Figure A5-32. Off-stream stock water system just outside the Scott River riparian zone. Photo taken in July 1997.

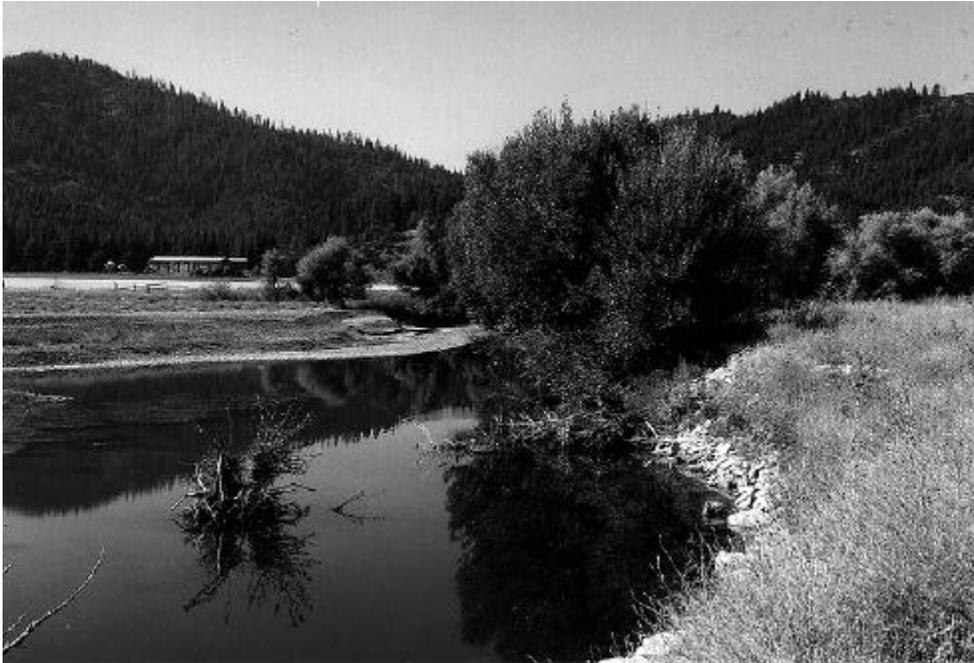
Figure A5-34. Bank stabilization project on the mainstem Scott River at Pastures of Heaven, combining rip-rap with tree planting. Photo July 1997.

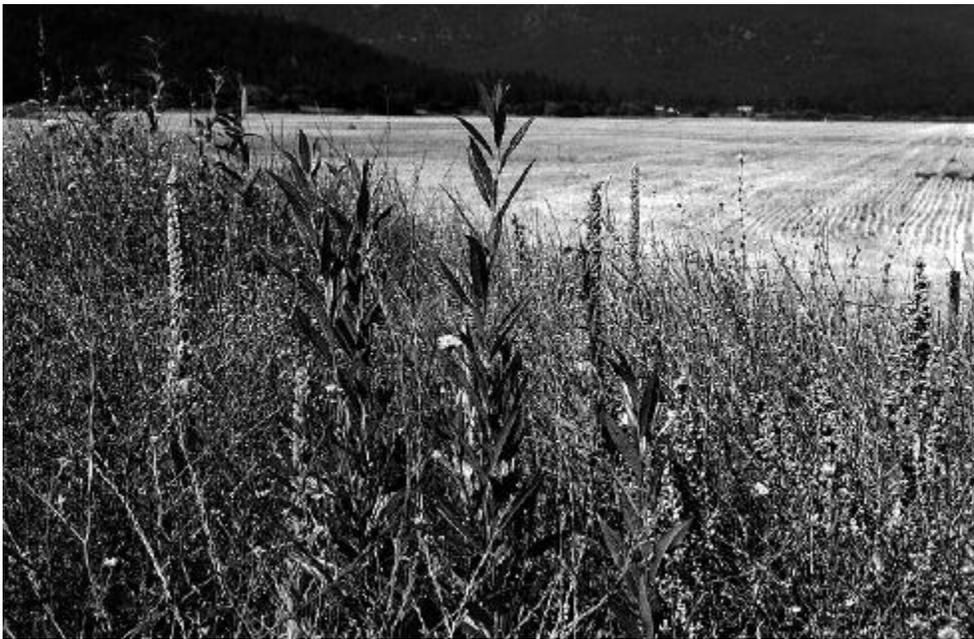
Figure A5-35. Deep-planted cottonwood stakes survived high flows of 1997 at Pastures of Heaven along the Scott River. July 1997.

Willows, cottonwoods and conifers have been planted extensively in Scott River riparian areas. Grubbing away competing plants before planting improves survival of tree starts. Over 23 acres were being planted during the summer of 1997 alone (Gary Black, personal communication). Getting trees established is difficult because the Scott River runs within levees at many locations and trees planted along its banks may be well above the water table. Two methods have been used to help get riparian trees established: drip irrigation and deep planting of long stakes or poles. Success of drip irrigation was increased by allowing periods with no water so that the young trees send down taproots. Shade cards are necessary to prevent burning in some locations, such as exposed gravel bars (Gary Black, personal communication). The most successful planting method is digging a hole 6-7 feet deep and planting long, stout cuttings of willow or cottonwood (Figure A5-35).

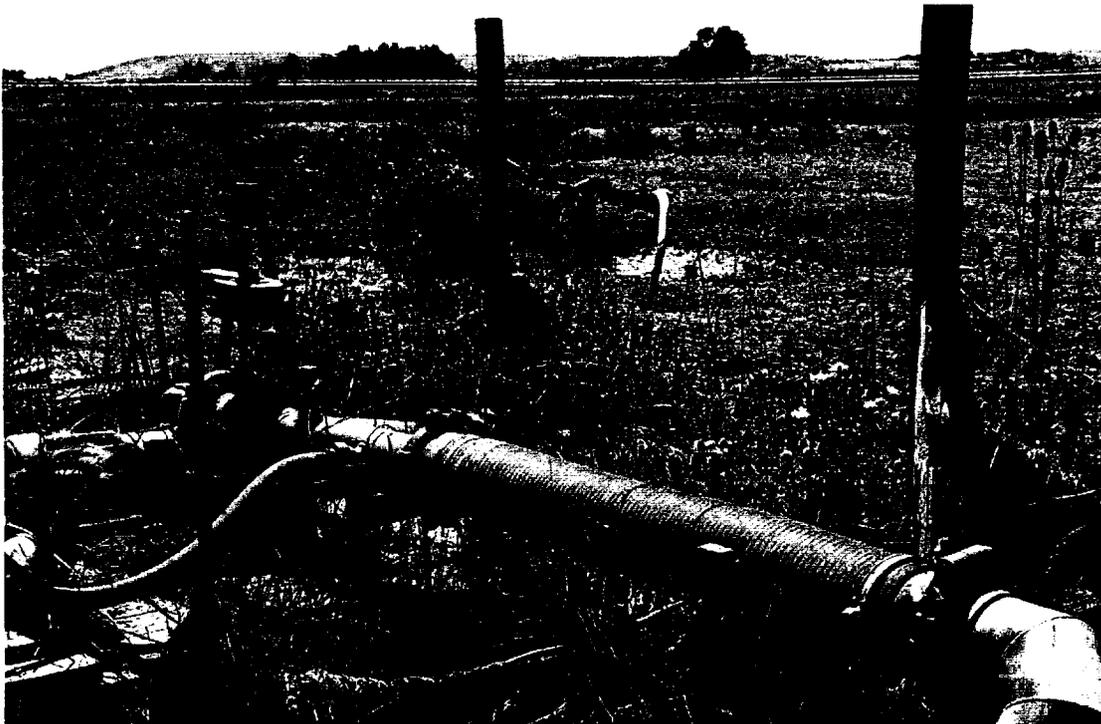
Figure A5-37. Pump installed at Fiock Ranch to eliminate the need for a diversion dam on the lower Shasta River. Dam removal should help improve dissolved oxygen conditions locally.

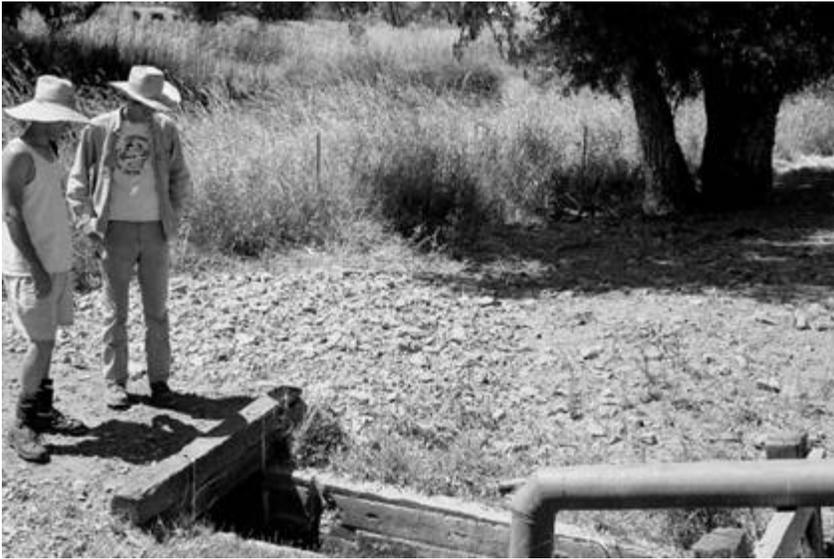
Figure A5-38. CRMP coordinator Dave Webb shows Jason Johnson of Kier Associates the sump pump for tailwater recovery at the Meamber Ranch on the Shasta River. July 1997.

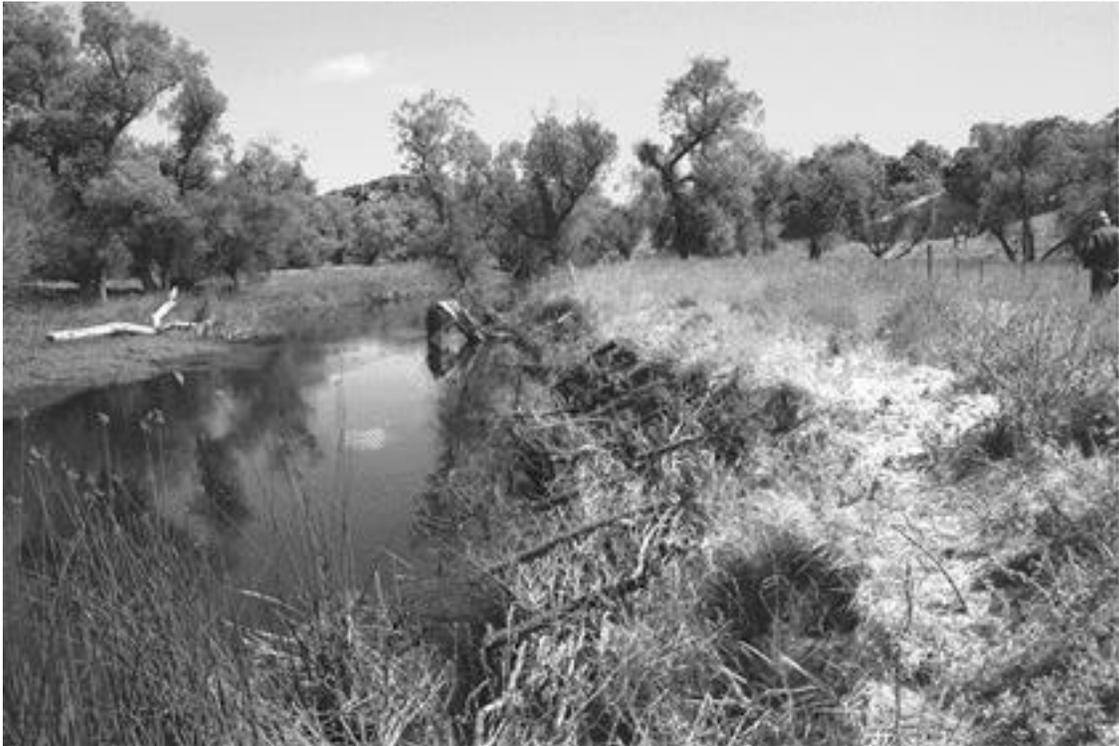
Figure A5-43. Willow waddles used for bank stabilization at the Easton Ranch along the Shasta River during project construction. Photo courtesy Dave Webb.

Bank stabilization using only willow waddles is a technique employed by the CRMP with a great deal of success at a number of sites on the mainstem Shasta River (Figure A5-43 and A5-44) and in Yreka Creek as part of the Yreka Greenway Project. Bundles of live willow sticks are secured to sections of eroding banks. Scour is prevented and silt from high flows is trapped. As the willows sprout and increase their root mass, bank stability and shade cover both result. There were no failures of willow waddle projects during the 1997 storms.

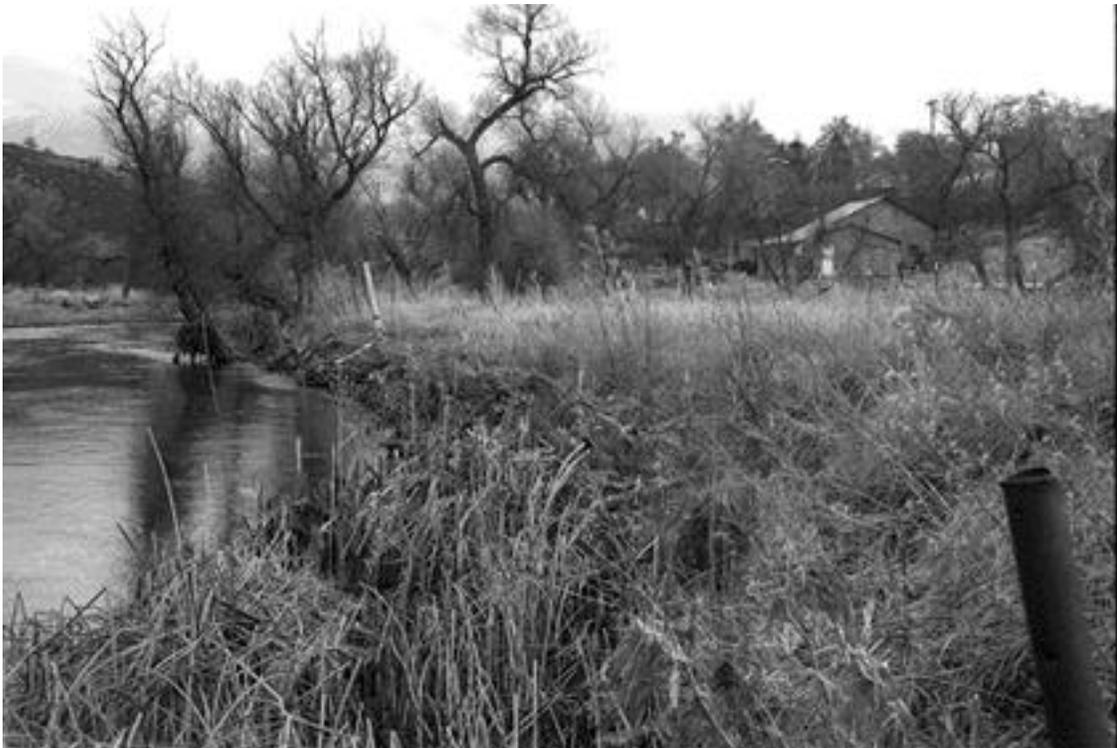
Figure A5-44. Stabilized bank at Easton Ranch after project completion. New willow starts in the foreground are not highly visible because the photo was taken in winter. Photo courtesy Dave Webb.

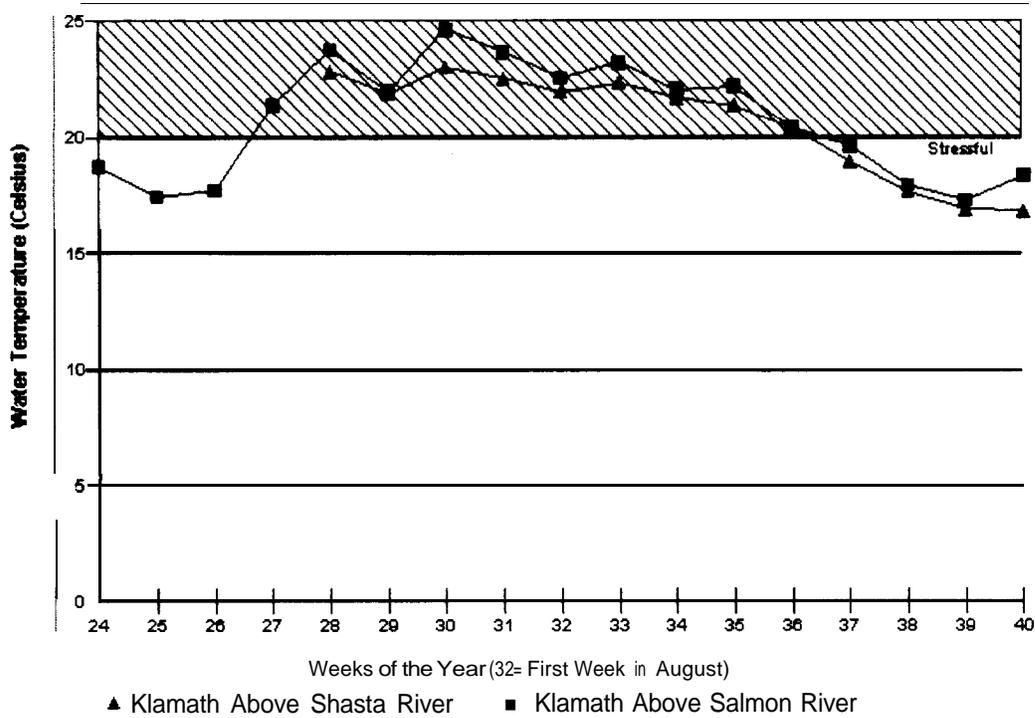
Figure A5-47. Average weekly water temperatures of the Klamath River above the Shasta and Salmon Rivers were chronically stressful for salmonids throughout the summer of 1996.

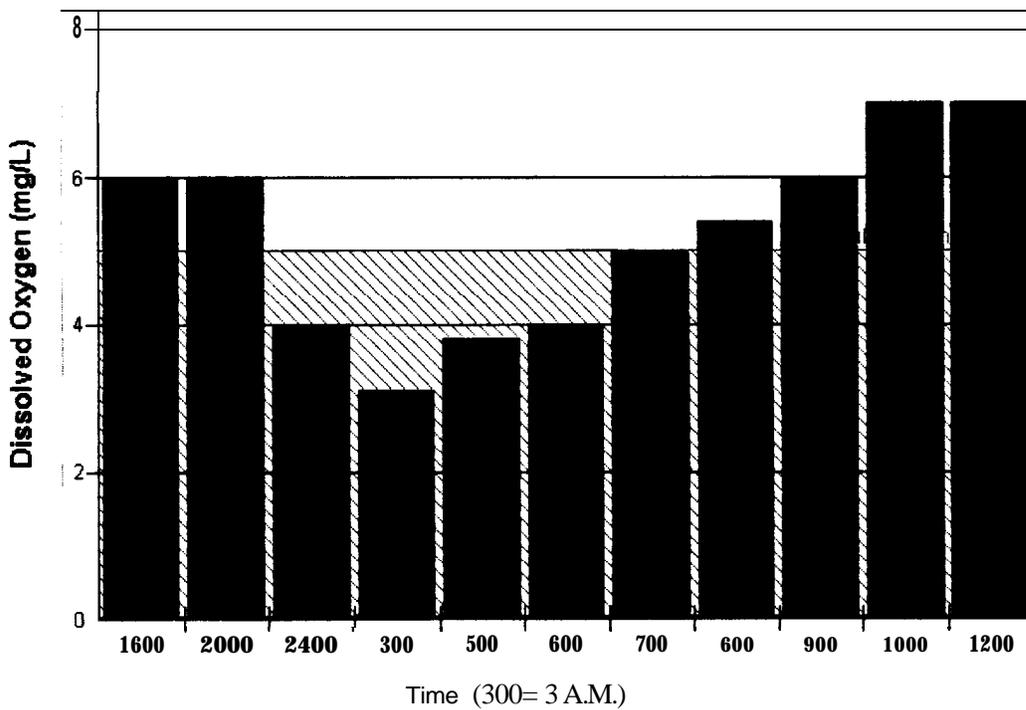
Figure A5-48. Dissolved oxygen readings taken by USFWS staff at Big Bar trap below Orleans on the Klamath River show stressful or lethal conditions for salmonids (<5ppm is stressful).

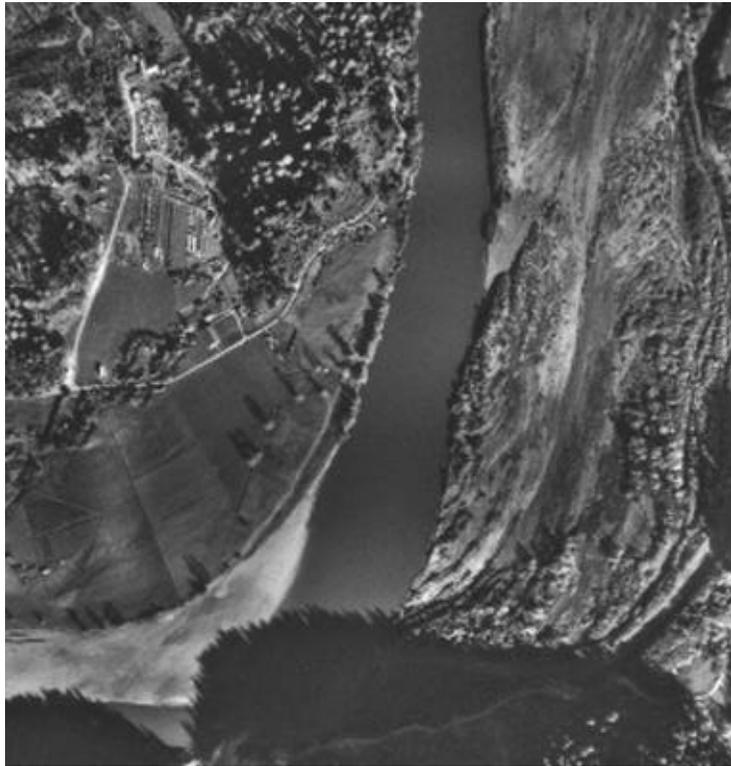
major aggradation of the lower Klamath River occurred in recent decades. This indicated by a distinct widening and shallowing from 1947-1996 (Figure A5-49 and A5-50). Note the blond colored areas within the active channel in 1996 that represent sand bars. These most recent photos do not show a marked trend toward recovery.

Figure 49. Lower Klamath River at the top of the estuary in 1941. Note that the channel is narrower than in the 1996 photo and that no sand bars are visible.

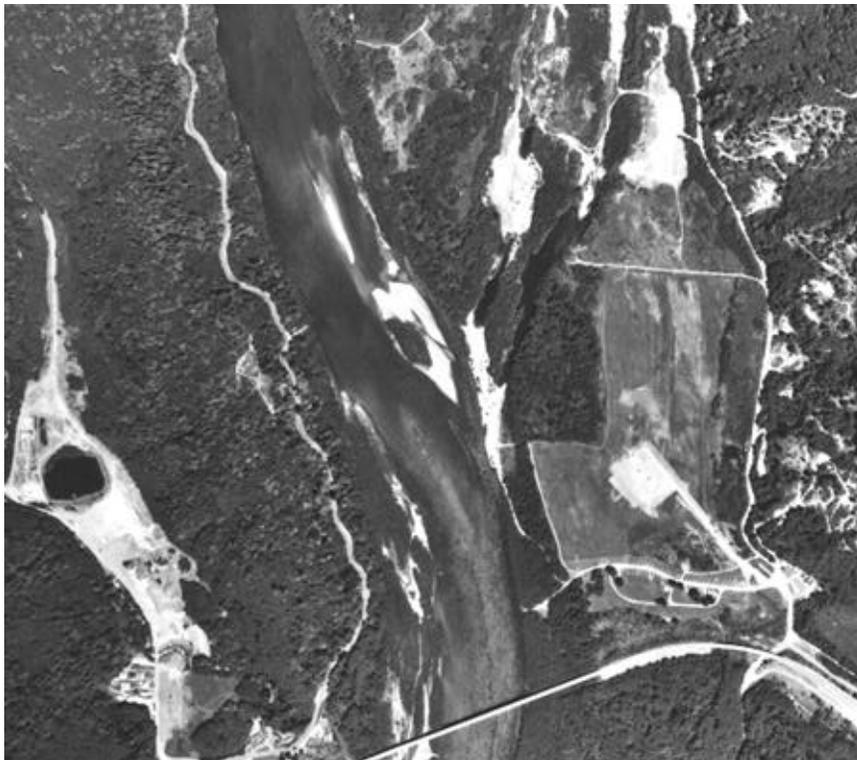
Figure 50. Aerial photo of the Klamath River at the top of the estuary in 1996 shows a wider riparian zone with sand bars both at the margins and in the main channel of the stream.

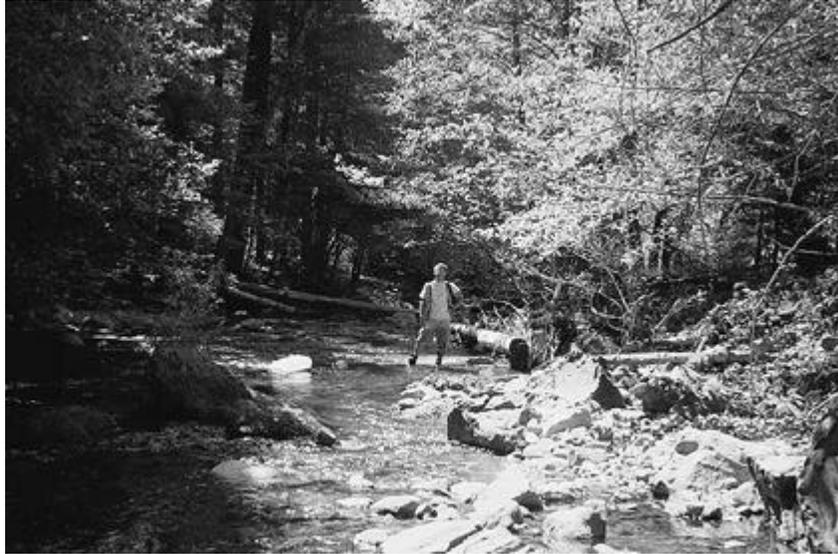
Cumulative effects damage to the Beaver Creek stream channel was significantly diminished above the West Fork. Although cables failed on wood structures in some cases, many of the wood and rock structures in the upper reaches survived intact (Figure A5-51). Some structure failures in upper Beaver Creek may have been owing to under-sized materials used in the original project (Figure A5-52). Logs were not large enough to withstand floods and some were rotting. Hopelain (in press) cited inappropriately sized materials as a prime cause of structure failure and suggested that projects for which proper materials were not available should not be implemented.

Figure A5-51. Upper Beaver Creek, shown here, did not experience the channel change that lower Beaver Creek did as a result of the 1997 storm. Note the wood and boulder structures still intact.

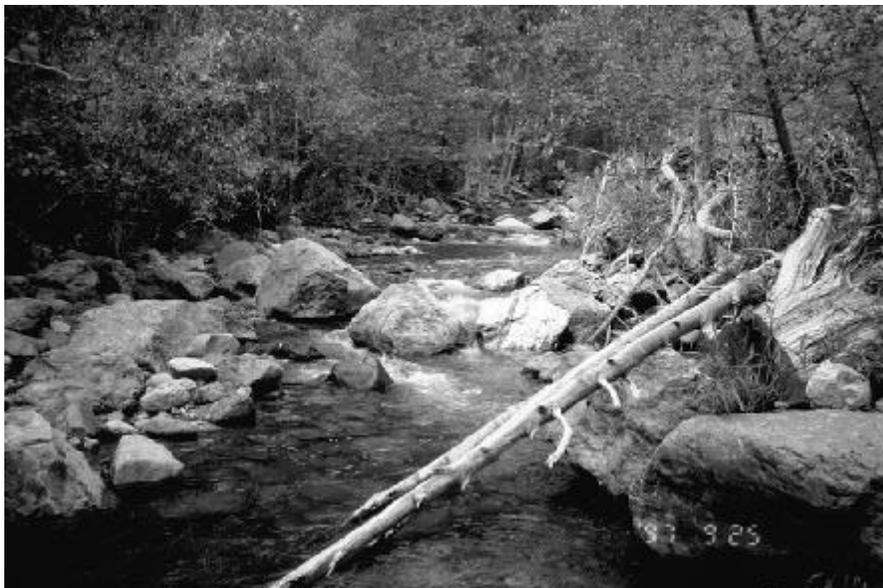
Flood damage at locations further upstream decreased somewhat. At RM 11.7 three of six boulder weirs were still in place (Figure A5-54). The three that had partially failed had lost boulders from the middle of the span. Upstream of the bridge at this location near the convergence with Luther Creek, aggradation had completely filled the rearing pond that had formerly occupied the site. The pond had formerly been 60' X 60' and six feet deep. Structures in Indian Creek above the bridge boulder clusters were also partially buried. Aggradation can vary in a stream like Indian Creek that may have lead to bedload build up where there was back-pressure from the bridge.

Figure A5-54. Boulder cluster and root wad in the margin of Indian Creek (RM 11.7) that survived the January 1997 storm intact. Photo courtesy of Al Olson, Klamath National Forest.

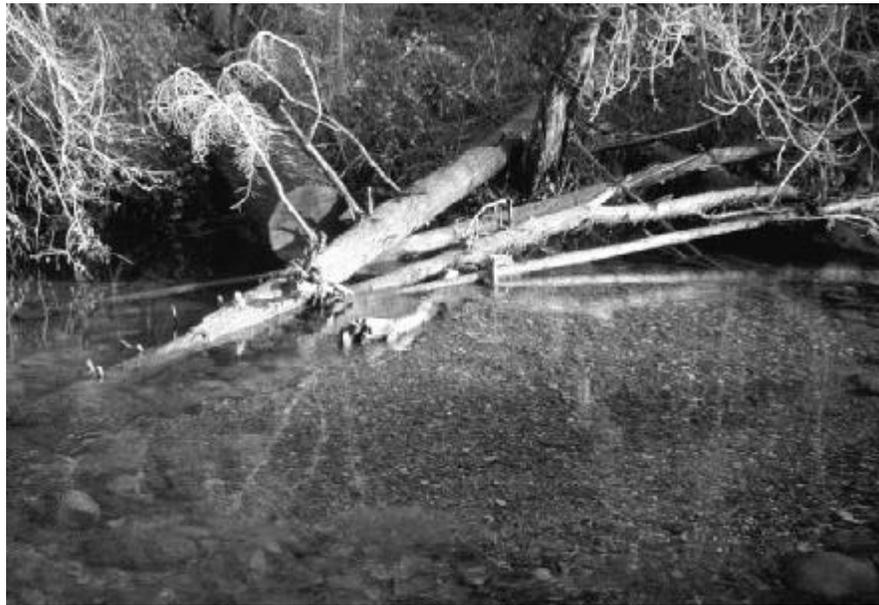
Figure A5-55. Complex log-cover structure in side channel of Elk Creek installed by Klamath National Forest. Photo courtesy of Al Olson. Circa 1991. Note spawning gravels adjacent to structure.

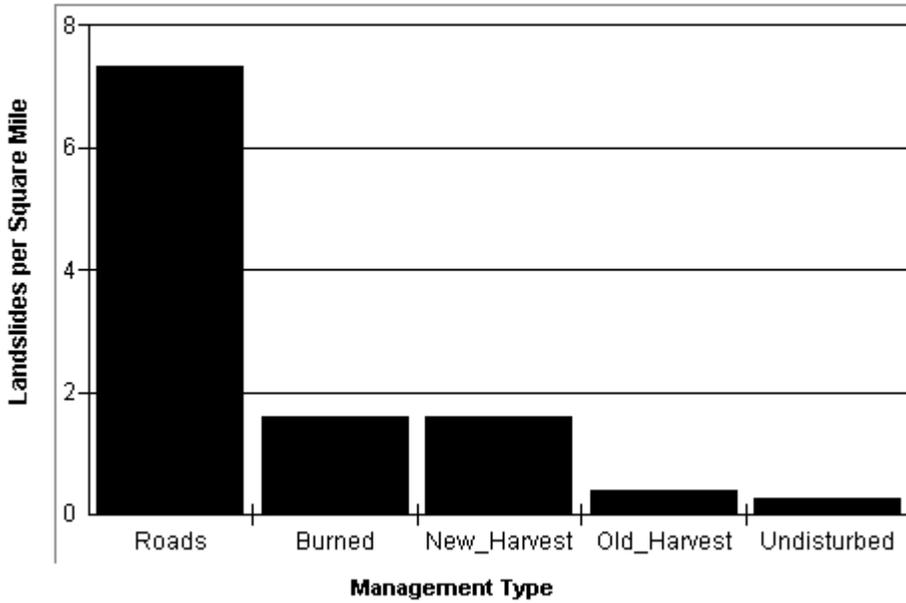
Figure A5-57. The number of landslides per square mile from various land management regimes. Data from De La Fuente (in press)

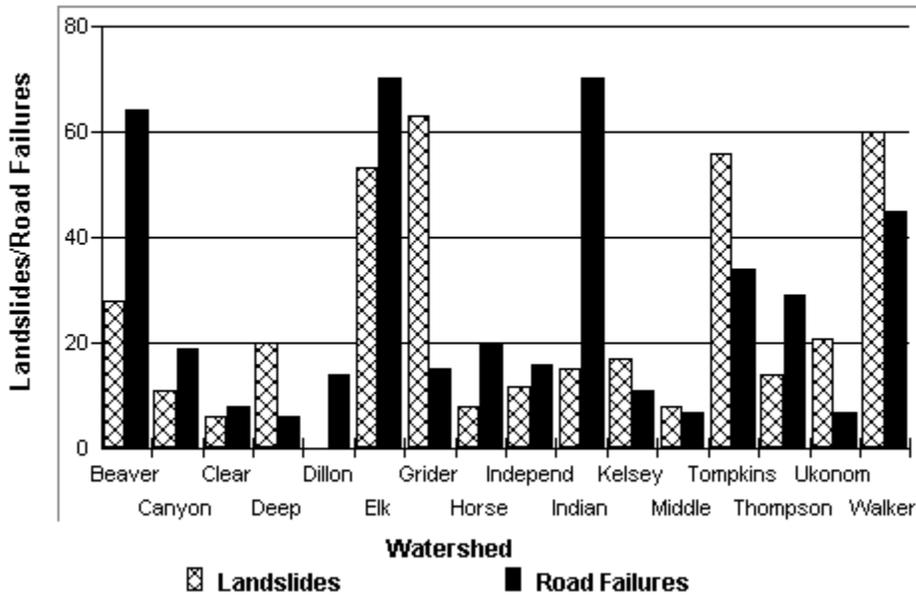
Figure A5-58. Landslides and road failures in various Klamath tributary watersheds. Data taken from De La Fuente (in press).

the fill material at each crossing is added to the debris torrent. Impacts to stream channels often continued into reaches at lower elevations. Many landslides and road failures occurred on old or active landslides or landslide deposits and in the inner gorge area adjacent to streams (De La Fuente, 1998).
